Transmission Speed Sensor: Customer Interest

Number:
05-40-011

Model:
1999 - SONATA,
2001 - ELANTRA, SANTA FE, XG
2003 - TIBURON
2005 - TUCSON

Subject
AUTOMATIC TRANSAXLE DIAGNOSTIC TROUBLE CODES P0715, P0717, P0720, P0721, P0722

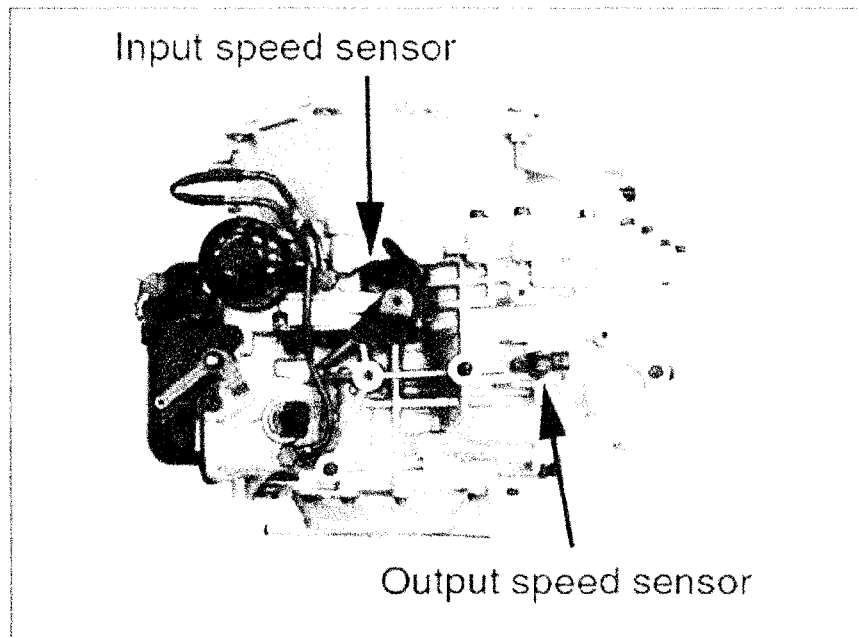
**CHECK
THE
SPEED
SENSOR
AND
HARNISS
AND
CONNECTORS.**

An improperly functioning input speed sensor or output speed sensor may result in the following four conditions:

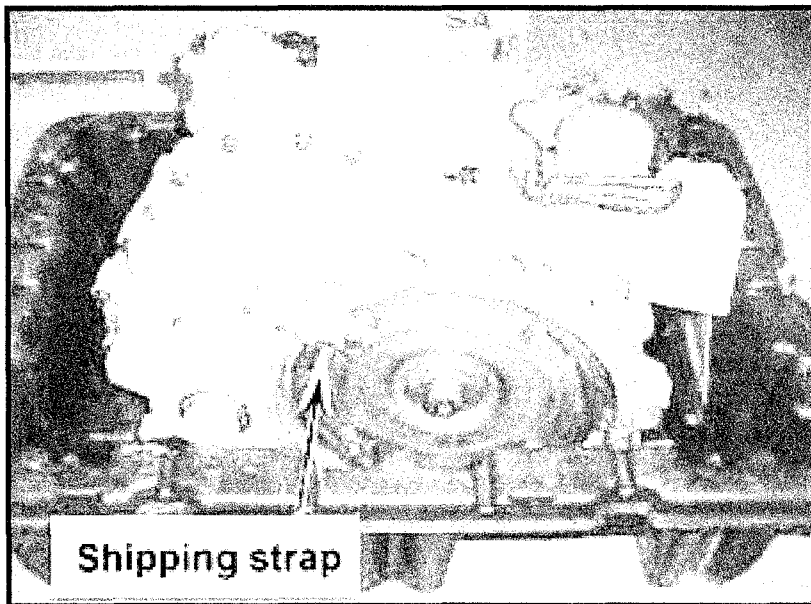
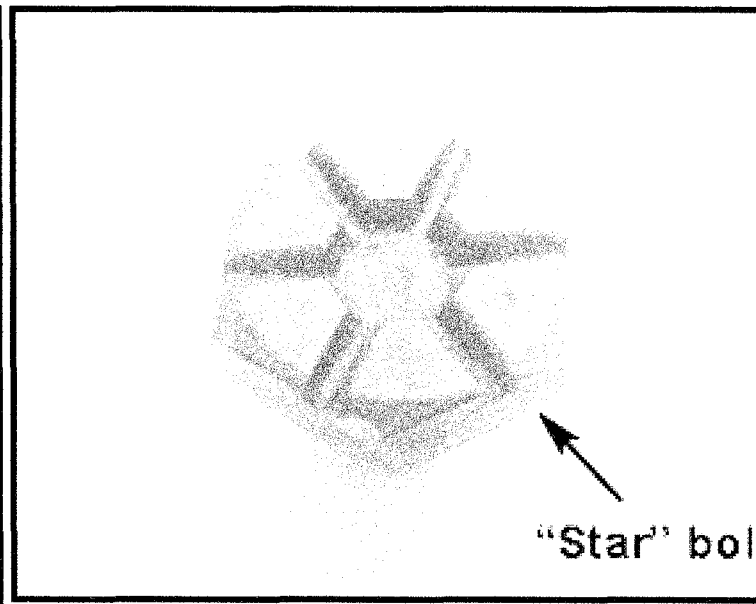
1. Loosen the 14mm bolt securing the shipping strap to the transaxle. Remove the bolt that secures the shipping strap to the torque converter. Check if the bolt is a "Star" bolt, (M10 x 1.25 x 11 mm, P/N 42121-21720):
 - ^ IF NOT, discard the bolt
 - ^ IF SO, retain the bolt
2. Use a light to inspect all the mounting bolt holes and threads for:
 - ^ An interference mark at the bottom of the hole indicating the existing bolt or a previous bolt has bottomed out and damaged the torque converter.
 - ^ Stripped threads caused by a bolt with incorrect threads.

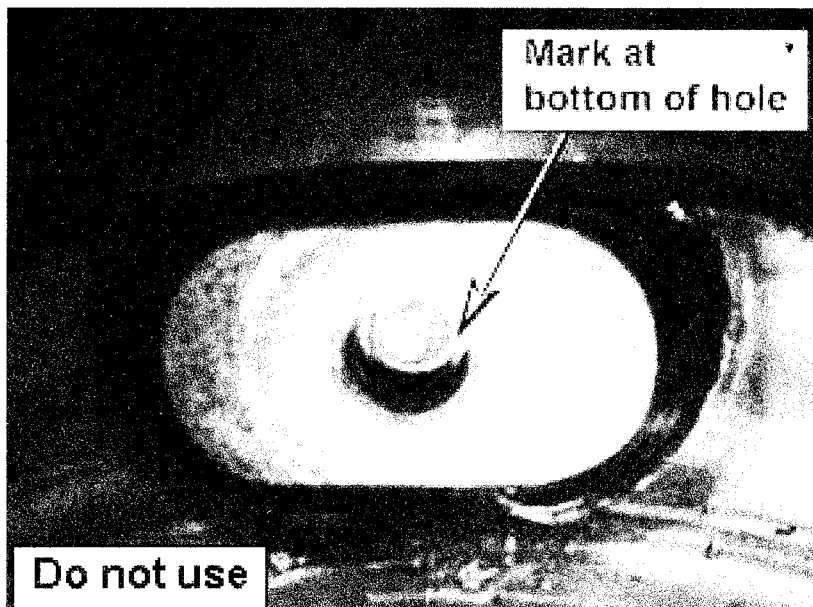
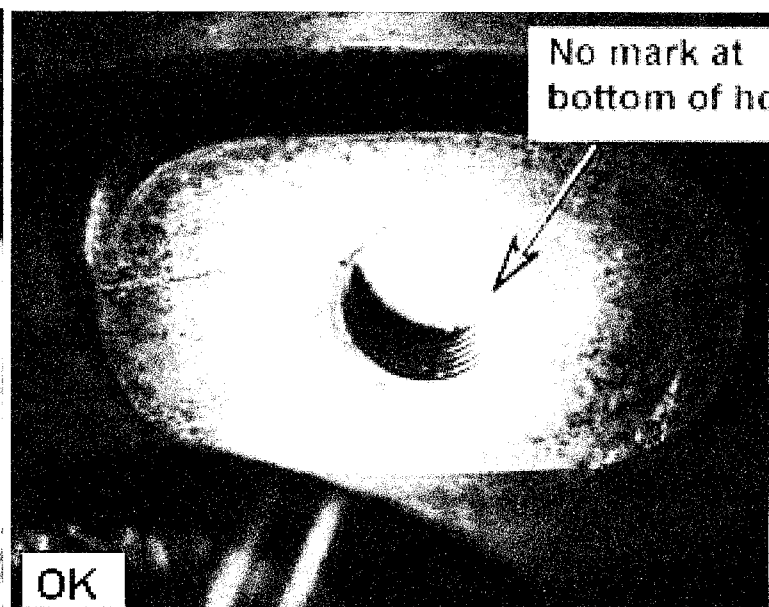
A mark indicating the existing bolt or a previous bolt has bottomed out:

- ^ No damage to either the mounting bolt hole or bolt threads - install the transaxle using 'Star' bolts to install the torque converter to the engine drive plate.
- ^ Damage to either the mounting bolt hole or bolt threads:
- ^ Install the shipping strap and use a "Star" bolt to secure the torque converter.
- ^ Write "Bolt holes damaged" on the Core Return Checklist.
- ^ Return the transaxle to the remanufacturer following the normal procedure.

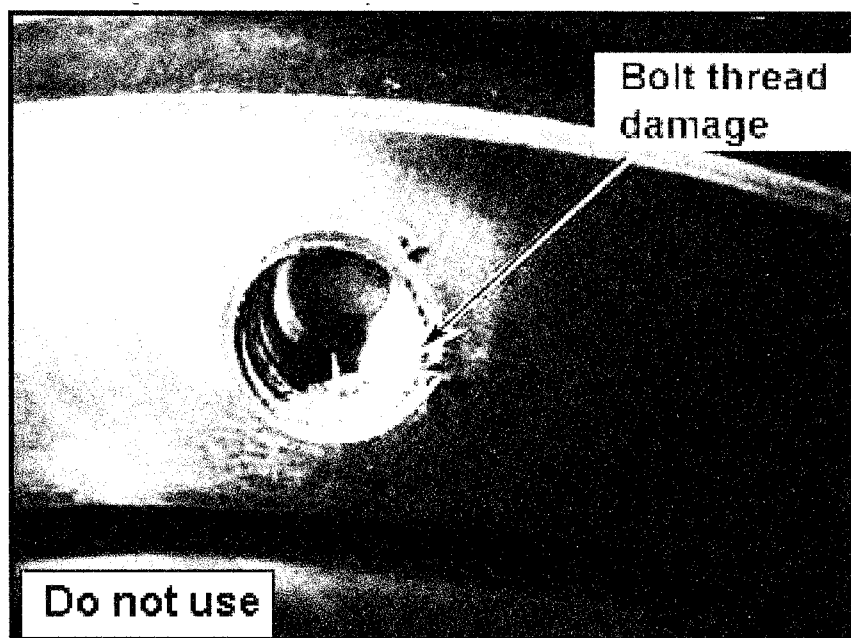
Damage caused by a bolt with incorrect threads:
