#01-06-01-007C: Engine Coolant Consumption or Coolant Leak (Inspect for Material Degradation/Replace Intake Manifolds) - (Sep 20, 2007)

Subject: Engine Coolant Consumption or Coolant Leak (Inspect For Material Degradation/Replace Intake Manifolds)

Models: 1995-1997 Buick Riviera
1995-1999 Buick LeSabre, Park Avenue
1996-1999 Buick Regal
1998-1999 Chevrolet Lumina, Monte Carlo
1995-1996 Oldsmobile Ninety-Eight
1995-1999 Oldsmobile Eighty-Eight
1998-1999 Oldsmobile Intrigue
1995-1999 Pontiac Bonneville
1997-1999 Pontiac Grand Prix
with 3.8L Engine (VIN K -- RPO L36)

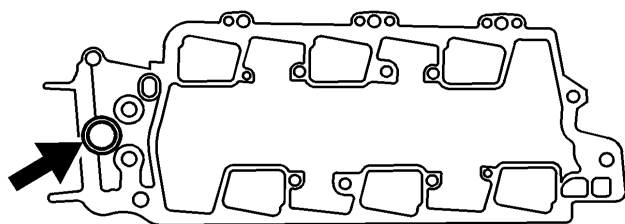
Upper intake manifold composite material may degrade around the EGR stove pipe and could result in an internal or external coolant leak.

2. Refer to the arrow in the illustration of the upper intake manifold above. Inspect the inner diameter of the EGR passage for signs of material degradation. Degradation will appear as "pitting" of the composite material in the EGR port passage.

3. If degradation of upper intake manifold composite material is found, replace the lower and upper intake manifolds with the following part numbers:
 - Gasket Kit, Upper Intake Manifold -- 89017554

- Manifold Kit, Upper Intake -- 89017272
 - Gasket, Lower Intake Manifold -- 89017400
 - Manifold, Lower Intake -- 24508923
4. Follow the lower and upper intake manifold installation instructions found in the Engine Unit Repair Section of the appropriate Service Manual.
