## HONDA ServiceNews

ASN 19504 (9802)

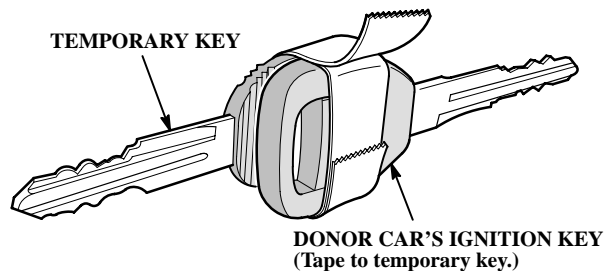
If you need to try a known-good ECM/PCM in a '98 Accord or Odyssey for testing purposes, use this shortcut instead of reprogramming the keys:

1. Cut a temporary ignition key for the car you're testing. Use a non-immobilizer key blank, P/N 35117-SM4-901, H/C 4225462.
2. Remove the ECM/PCM from the test car, and write the test car's VIN on it. (This way, you won't confuse it with the ECM/PCM from the donor car.)
3. Remove the ECM/PCM from the donor car, and install it in the test car.
4. Tape the ignition key from the donor car head-to-head onto the temporary key. The transponder in the donor car's key will allow you to start the engine with the temporary key.

5. When you've completed your testing, reinstall the test car's ECM/PCM, and destroy the temporary key.

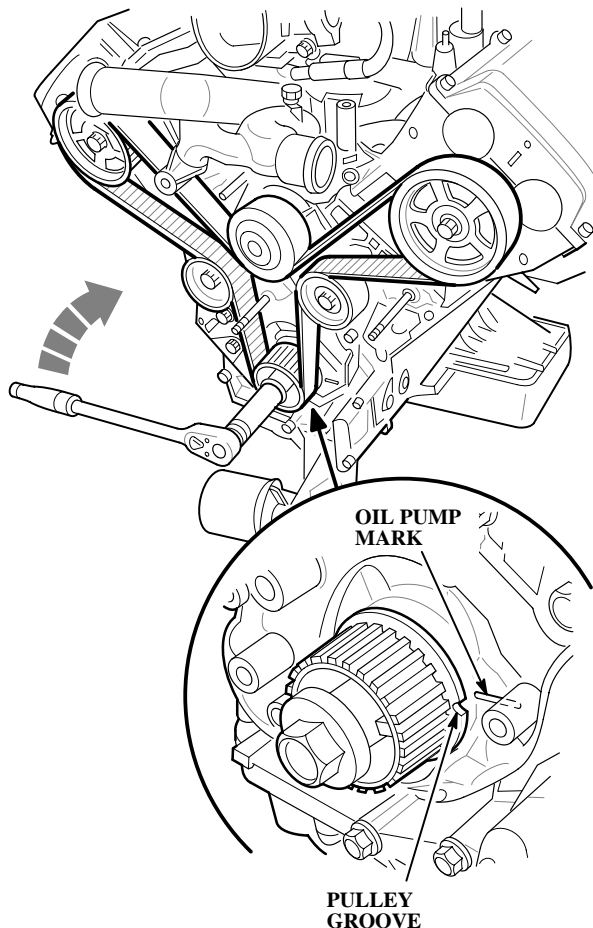
1. Turn the crank pulley with a socket and ratchet until the groove on the pulley lines up with the mark on the oil pump housing.

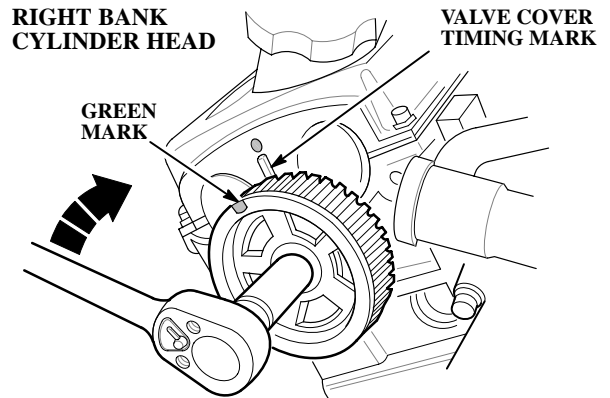
3. Turn the right bank (passenger's side) cam pulley clockwise with a socket and ratchet (the pulley will click and stop several times). The right bank cams are aligned when the pulley's green mark stops directly at the valve cover's timing mark. (You may need to rotate the pulley up to three complete revolutions before the green mark stops directly at the timing mark.)

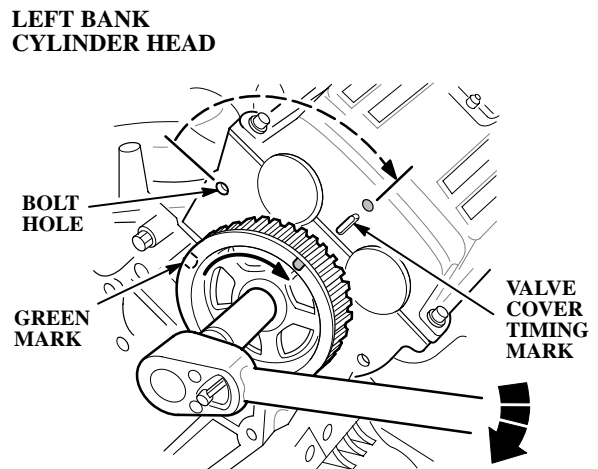
4. Turn the left bank (driver's side) cam pulley clockwise with a socket and ratchet (the pulley will click and stop several times). Stop the pulley when its green mark lines up with the timing belt cover bolt hole. (You may need to rotate the pulley up to three complete revolutions before the green mark stops directly at the hole.)

5. Move the left bank pulley another 1/4 turn clockwise until its green mark lines up with the valve cover's timing mark.
6. The crankshaft and camshafts are now ready for belt installation. Install the timing belt as shown in section 6A1 of the '98 SLX S/M.

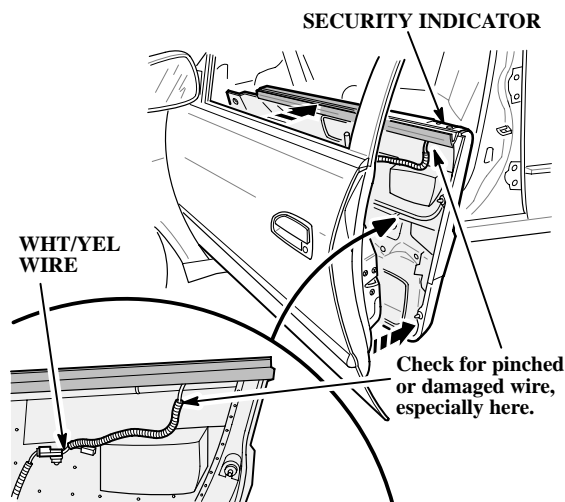
If fuse No. 13 in the passenger's under-dash fuse/relay box blows repeatedly, here's what to do:

1. Remove the driver's door panel.
2. Trace the routing of the security indicator's WHT/YEL wire. If the wire is pinched or damaged, repair it, and then reroute it so nothing interferes with it. (Damage is usually caused by the wire getting pinched by a clip on the door panel inner molding.)

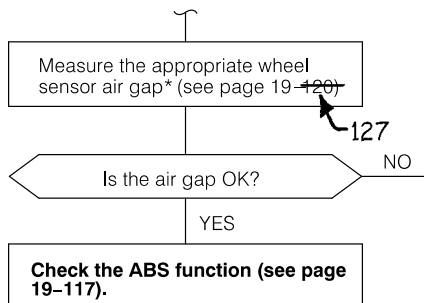
On page 19-88 of the '97 Accord S/M, the wheel sensor troubleshooting chart leads you to the wrong page to measure the wheel sensor air gap. Please write in the correct page number as shown below.

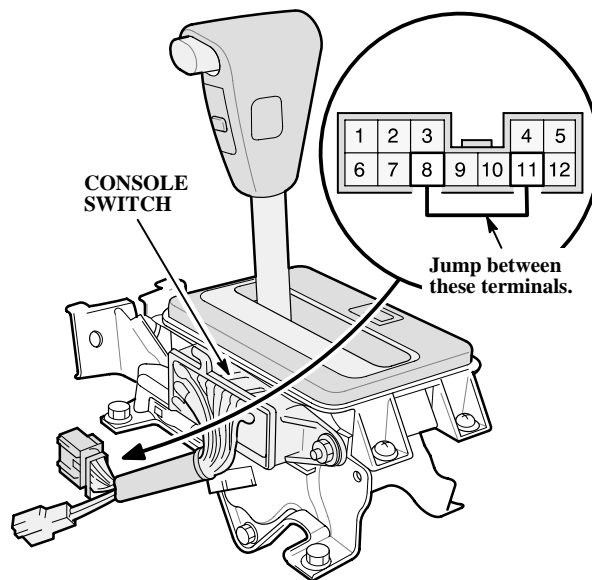
If the ignition key can't be removed, the shifter is stuck in Park, and the "P" light on the shift indicator doesn't work, you may have an open circuit in the shift position console switch. To check it, do this:

1. Remove the front console.
2. Connect a jumper wire between terminals 8 and 11 (the BLK wire and the GRN/WHT wire) of the 12P connector on the shift position console switch.

- If the ignition key, shifter, and shift indicator work when the jumper wire is connected, replace the switch, P/N 35700-SM4-A91, H/C 3278306.
- If they don't work, test the switch (see page 23-136 of the '90 Accord S/M).

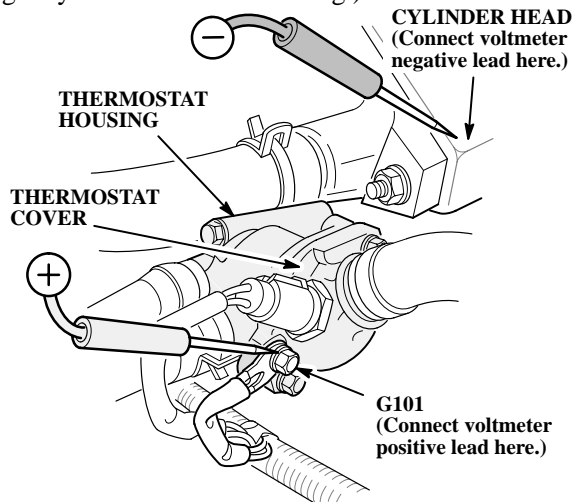
On '84-98 Civics, the ECM/PCM and all PGM-FI electrical components share ground location G101. Bolted to the thermostat housing, G101 can get corroded and cause too much resistance in systems that are controlled by the ECM/PCM. To check the ground, run this voltage drop test:

1. Connect the leads of a voltmeter as shown. (Don't connect the negative lead to the thermostat housing; corrosion between the housing and the head will give you an inaccurate reading.)

2. Start the engine, and snap the throttle wide open to load the circuit.
  - If the drop is less than 0.5V, the ground is OK.
  - If the drop is more than 0.5V, remove the thermostat cover, and clean the cover and housing mating surfaces. Usually, this solves the problem.
