^ Transmission: 41TE/A604
^ Subject: Intermittent limp-in/Fault codes
^ Application: Chrysler

41TE/A604

Intermittent Limp-in/Fault Codes

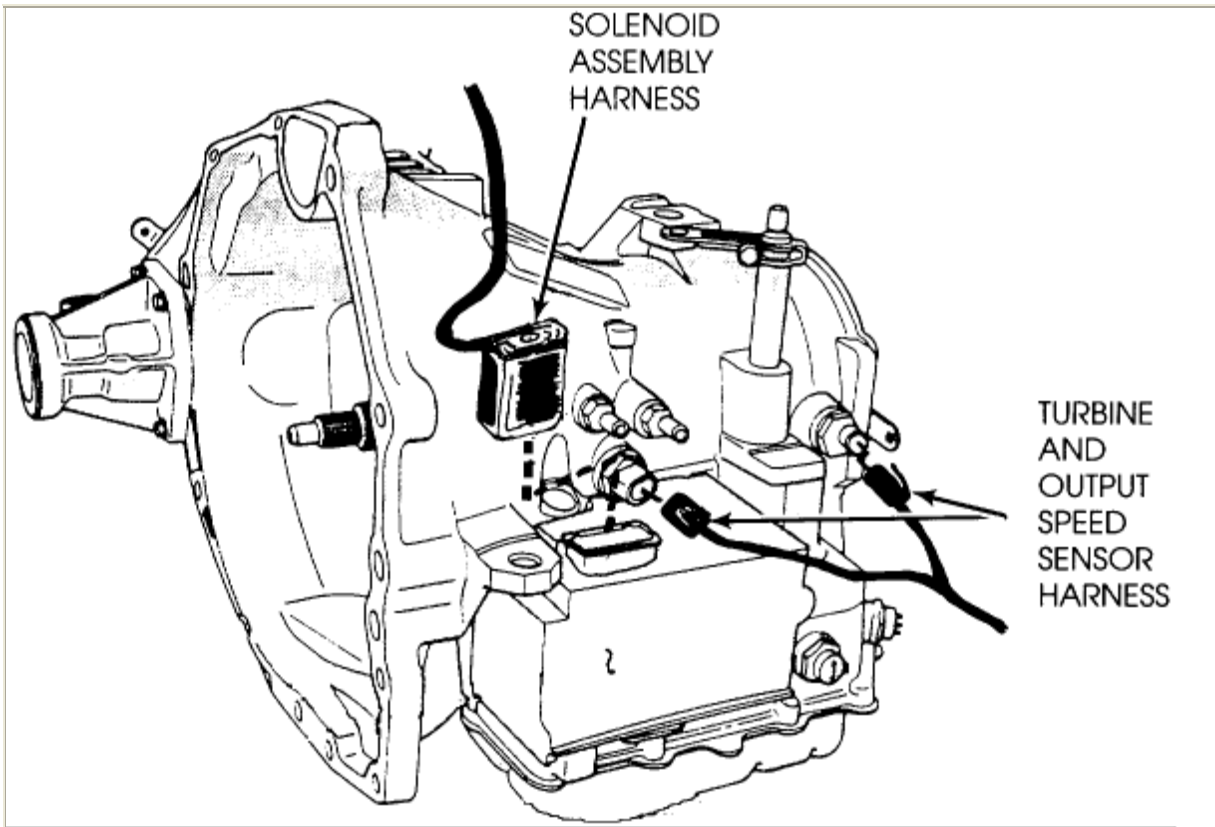
An intermittent limp-in/fault codes condition can be caused by poor electrical connections to any of the input/output devices used by the controller. Make sure all of the connections are tight and there are no bent terminals in the connectors.

Chrysler has two repair kits available in the event that the harness connector for the speed sensors or solenoid assembly are damaged. The part numbers are listed below.

Solenoid harness repair kit 4419476
Speed sensor harness repair kit 4419478
