Transmission Speed Sensor: All Technical Service Bulletins Service Procedure

PULSE GENERATOR-B INSPECTION PROCEDURE:

TCM REPROGRAMMING PROCEDURE:

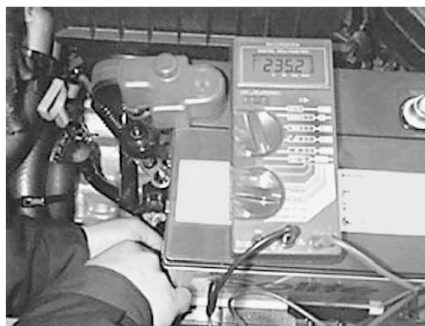
3. Locate the pulse generator under the battery tray. Disconnect the pulse generator connector (blue) and remove the pulse generator male connector (black) from the bracket.

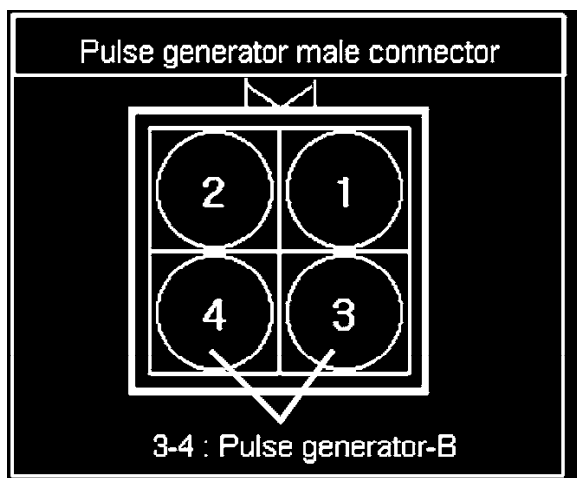
4. Using an ohmmeter, check the resistance between terminal No. 3 and No. 4 in the disconnected pulse generator male connector (black color).

Resistance value:

215-275W (at 20°C or 68°F)

If the resistance is lower or higher than the specification, replace the pulse generator (P/N 45955-22700).

If the resistance is within specification go to Step 5.
