RECALL CAMPAIGN BULLETIN

NTB03-112

VOLUNTARY RECALL CAMPAIGN ELECTRONIC CONTROL MODULE (ECM) CASE HOLDER FOAM

APPLIED VEHICLES: 2000-2003 Sentra (B15)

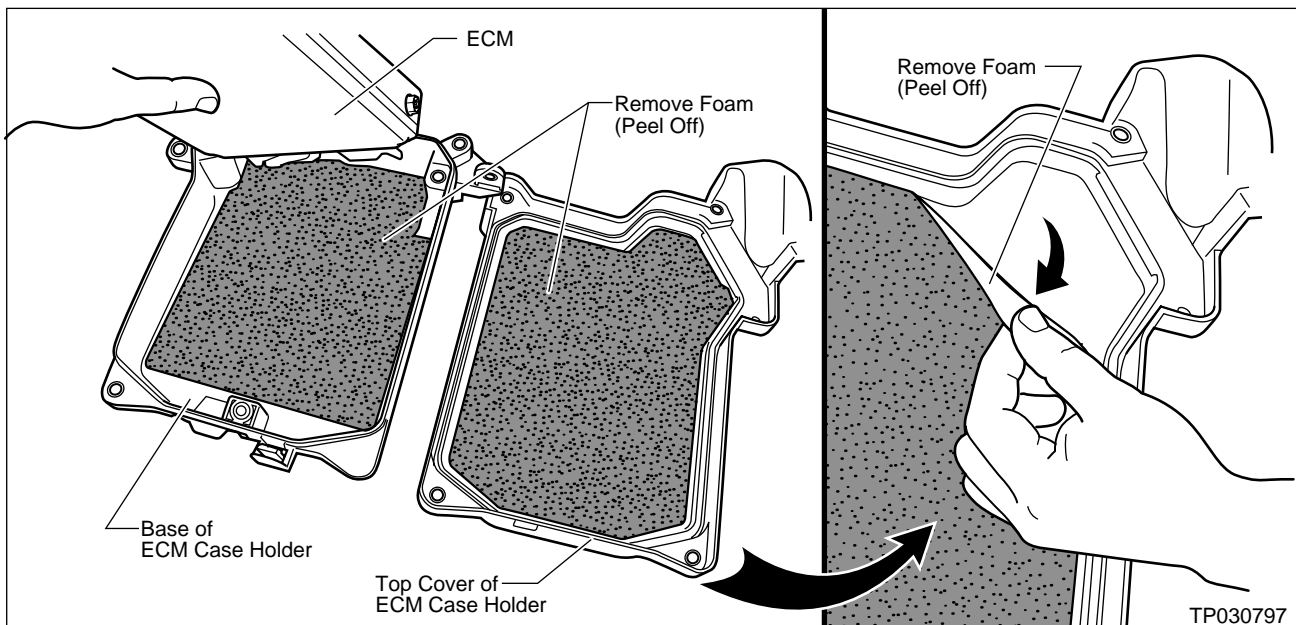
Figure 10

On some 2000-2003 model year Nissan Sentra vehicles described above, there is a possibility that the engine may stop running while being driven due to contamination of the Engine Control Module (ECM) by the inner lining material. This may also result in the "Service Engine Soon" light coming on or poor driveability. If the engine stops running while driving, this could result in a crash without warning.

10. Lift UP the ECM and remove/discard the Foam from the Base and Top Cover of the ECM Case Holder (see Figure 10).

- Make sure you remove/discard all the Foam and that the Base and Top Cover are clean and free of dirt, dust, and debris.
