UPPER BALL JOINT EXTENDED WARRANTY

TECHNICAL SERVICE BULLETIN

Reference Number(s): 02-010-04, Date of Issue: December 16, 2004

CHRYSLER: 2000 - 2003 (AN) Dakota 4x2; 2000 - 2003 (DN) Durango 4x2

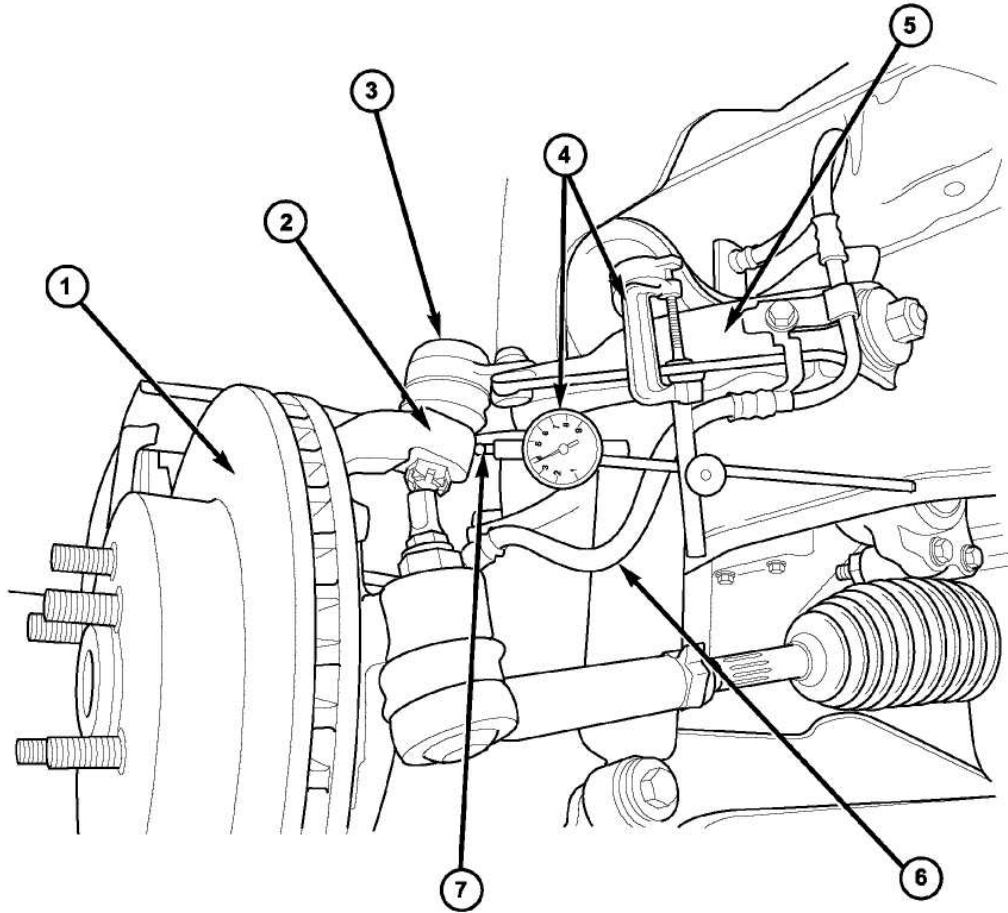
Fig. 1: Right Side View Of Suspension (Wheel/Tire Removed For Clarity)

4. Position the dial indicator plunger against the back side of the steering knuckle boss for the upper ball joint (**Fig. 1**).
5. Zero the dial indicator **while pulling outward on the top of the tire**.
6. While an assistant watches the dial indicator gauge, grasp the top of the tire and push inward. Record the dial indicator reading observed from the full outward to full inward position.
7. Repeat Step #1 through Step #6 on the left side upper ball joint. When both the left and the right upper ball joints have been inspected, proceed to Step #8.
8. Based on the results recorded in Step #6:

- a. If the lateral movement on both upper ball joints is less than 0.060 in. (1.52 mm), no further action is required. Remove the dial indicator, lower the wheel and return the vehicle to the owner.
- b. If the lateral movement on either of the upper ball joints is greater than 0.060 in. (1.52 mm), replace both upper ball joints as described in the Repair Procedure.
