SERVICE BULLETIN

Classification: BT05-005a	Reference: NTB05-064a	Date: March 20, 2008
------------------------------	--------------------------	-------------------------

CENTER CONSOLE FRONT LID WILL NOT CLOSE

APPLIED VEHICLES: 2005 – 2006 Altima (L31)

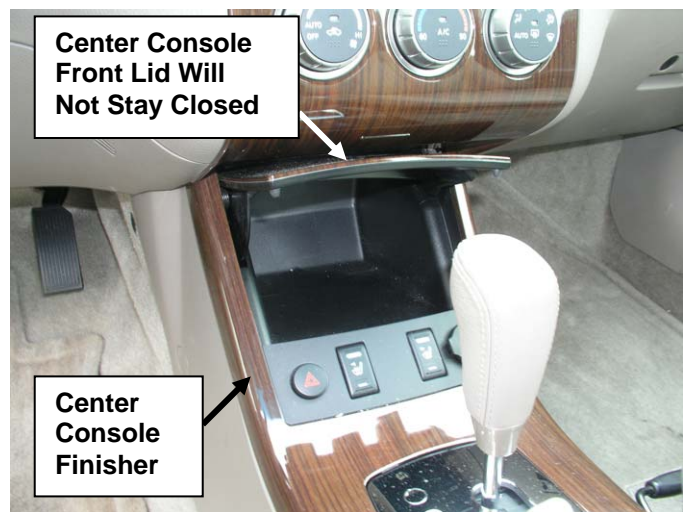
Figure 1

An applied vehicle has a Center Console Front Lid that will not stay closed (see Figure 1).

Install a new Linkage/Latch on the LH side of the Center Console Finisher.
