**Wind Noise From the Windshield****(Supersedes 04-078, dated April 11, 2006, to update the information marked by the black bar)****SYMPTOM**

Wind noise from the windshield area while driving the vehicle.

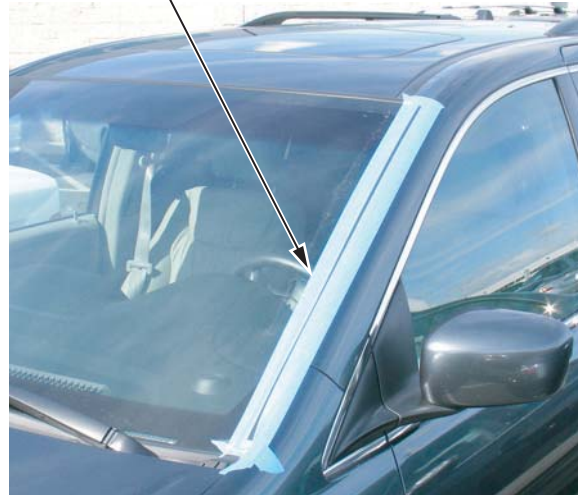
MASKING TAPE

1. Verify the noise by driving the vehicle at highway speeds.
 - If you hear wind noise coming from the windshield area, go to step 2.
 - If there is no wind noise, or the noise is coming from a different location, this service bulletin does not apply.
2. Cover all the edges of the windshield side trim on the driver's side with masking tape, as shown.

3. Test-drive the vehicle under the same conditions as in step 1.
 - If the wind noise is gone, do **Repair Procedure B** to the driver's side.
 - If you still hear wind noise, go to step 4.
4. Cover all the edges of the windshield trim on the passenger's side with masking tape.
5. Test-drive the vehicle under the same conditions as in step 1.
 - If the wind noise is gone, do **Repair Procedure B** to the passenger's side.
 - If you still hear wind noise, do **Repair Procedure A**.
