Creaking From A-Pillar When Turning Left: '02 CR-V

ASN 24900 (0301)

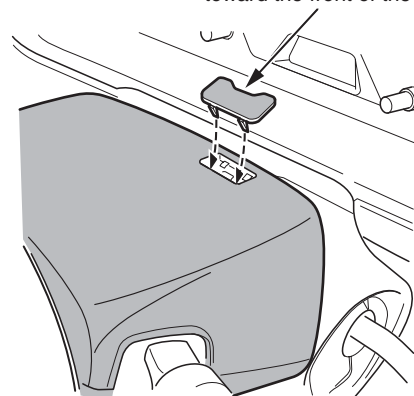
ODYSSEY:

The opening on the shift lock release slot cover points toward the front of the vehicle.

When you reinstall the shift lock release slot cover on a '99-03 Odyssey or '03 Pilot, be really careful. The cover is made to snap into the opening in the upper steering column cover in just one direction. If you try to install the cover in the other direction, you'll break off its retaining clips. And as an extra precaution, make sure you snap in the side with the two *straight* retaining clips first, then the side with the two *angled* clips.

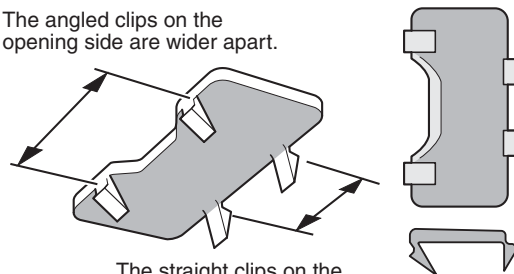
The angled clips on the opening side are wider apart.

The straight clips on the other side are closer together.

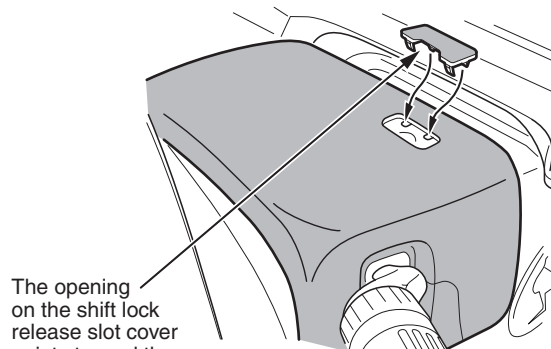
PILOT:

The opening on the shift lock release slot cover points toward the back of the vehicle.
