**FORD:**  
2007-2008 Edge

**LINCOLN:**  
2007-2008 MKX

This article supersedes TSB **07-7-6** to update the original TSB to add model years. No other changes made.

## TSB 08-7-3 (Continued)

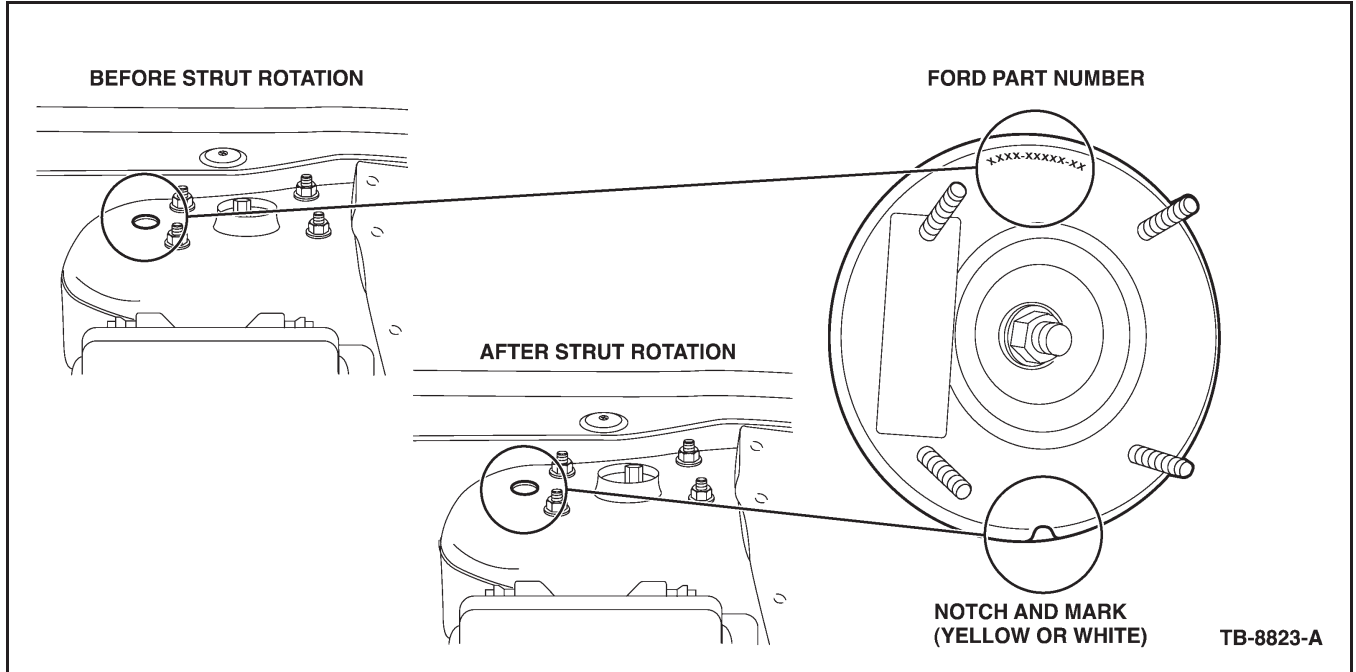
Figure 1 - Article 08-7-3

Some 2007-2008 Ford Edge and Lincoln MKX vehicles may exhibit a drift/pull concern that occurs even though the tire pressures and wheel alignment are within specifications, and the concern is not corrected by rotating the front tires left to right.

**IF THE NOTCH IS VISIBLE IN THE ACCESS HOLE IN THE STRUT TOWER, THE PLATE HAS ALREADY BEEN ROTATED A POSITIVE 0.5 DEGREE.**

2. If the arrow is pointing inboard as seen through the access hole in Figure 1, no rotation is necessary (positive 0.5 degree camber already there). Continue with Step 4.

1. Inspect the left strut upper plate to verify which direction the arrow is pointing. (Figure 1)

3. If the arrow is pointing outboard, increase positive camber approximately 0.5 degrees on the left front wheel by rotating the upper strut plate 180 degrees. Refer to WSM, Section 204-00, Camber Adjustment - Front.

1. Inspect the right strut upper plate to verify which direction the arrow is pointing. (Figure 1)

2. If the arrow is pointing inboard, as seen through the access hole in Figure 1, no rotation is necessary (positive 0.5 degree camber already there). Continue with Step 4.
3. If the arrow is pointing outboard, increase positive camber approximately 0.5 degrees on the right front wheel by rotating the upper strut plate 180 degrees. Refer to WSM, Section 204-00, Camber Adjustment - Front.
