**6.0L—BUILT ON OR BEFORE 9/29/2003—DTCS P006A
OR P132B—LACKS POWER, SURGE, OR FLUTTER
AFTER FIELD SERVICE ACTION 06E17**

TSB 06-24-6

2003-2004 Excursion, F-Super Duty

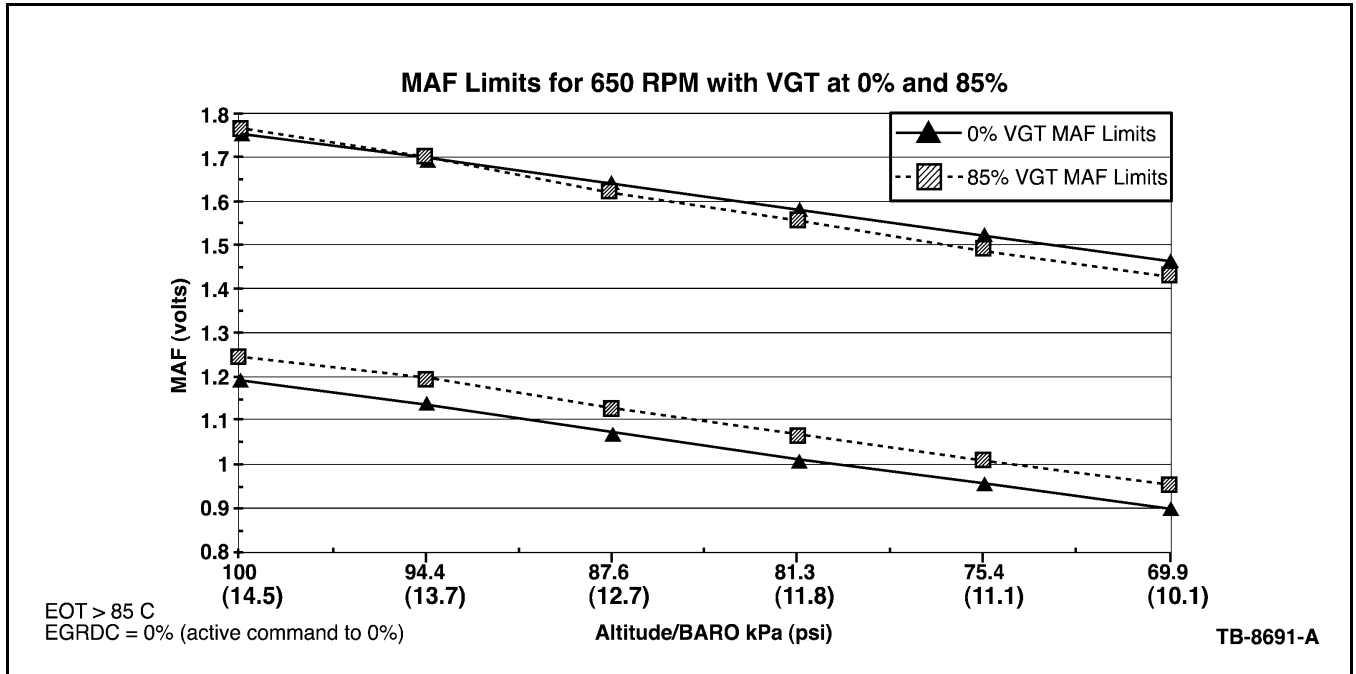
Figure 1 - Article 06-24-6

- (6) 1200RPM VGTDC=85%
 - c. Compare the voltage to Figures 1 and 2. Outside of MAF limits and/or recorded value is lower than limits, possible causes:

- (1) MAF sensor
 - (2) Air leak between MAF sensor and turbo
 - (3) Aftermarket Air Intake system
 - (4) Leaking EGR O-ring or gasket
 - (5) Exhaust restriction

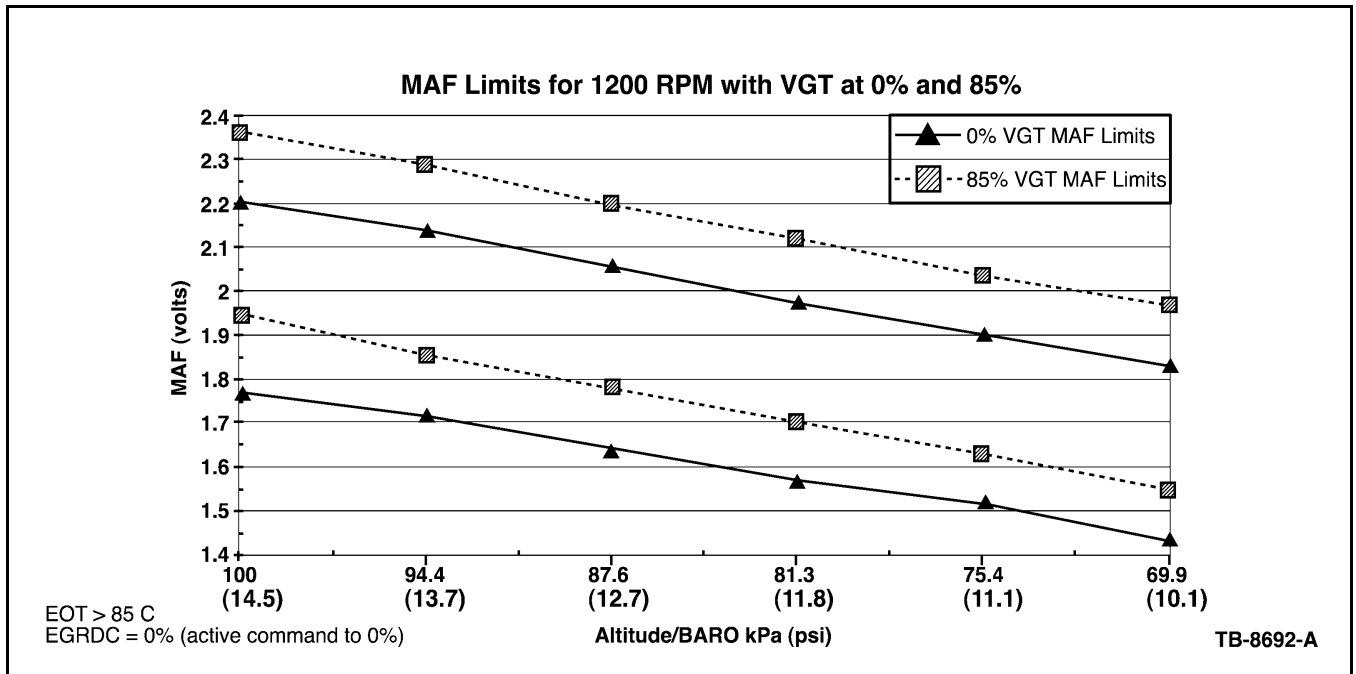
Figure 2 - Article 06-24-6

- d. Compare the voltage to Figures 1 and 2. Recorded value is higher than limits, possible causes:
 - (1) MAF sensor
 - (2) Air Leak in the charge air cooler (CAC) system

- (3) Dirty Air Filter
 - (4) Aftermarket Air Intake System
 - e. Verify the MAP/BARO correlation. Are they within 1.0 psi (6.9 kPa) of each other? If not, follow the appropriate PPT diagnostic and repair.
