Product Update: Drive Belt Auto-Tensioner Pivot Bolt Replacement

Product Update: Rerouting the Drive Belt

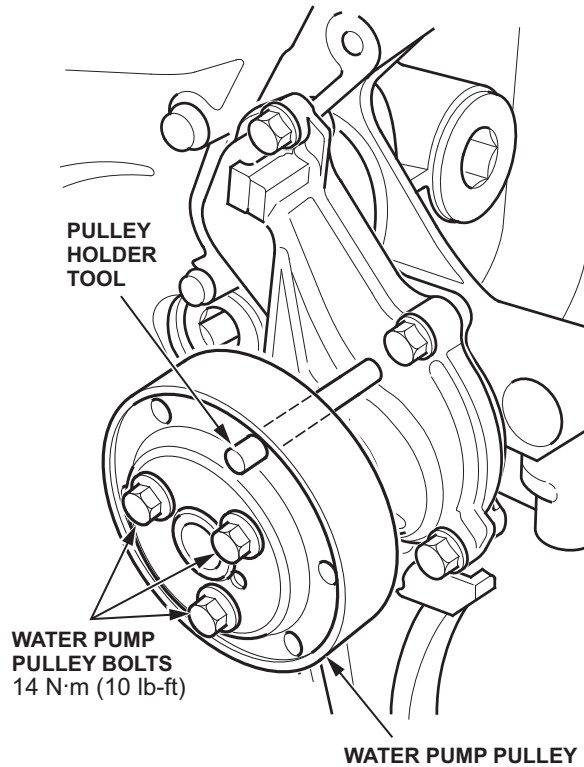
2. Insert a pulley holder (see REQUIRED SPECIAL TOOLS) into one of the holes in the water pump pulley at the 12 o'clock position. The tool holds the pulley so you can loosen or tighten the pulley bolts.

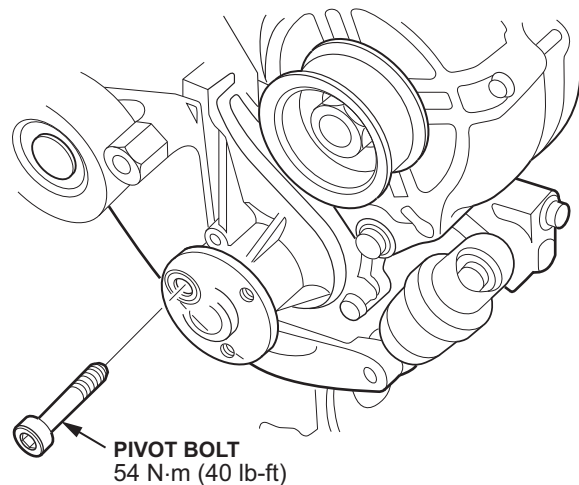
3. Remove the water pump pulley (three bolts).
4. Remove the pivot bolt from the drive belt auto-tensioner.

NOTE: In rare cases, the pivot bolt may be broken. If this has happened, remove the auto-tensioner, then remove the shank of the pivot bolt with Vise Grips or by drilling it out. *Do not try to repair the engine block using a TIME-SERT.* If you can't remove the shank of the pivot bolt, you would need DPSM approval to install an engine short block assembly.

- Install a new pivot bolt on the auto-tensioner, and torque it to **54 N·m (40 lb-ft)**.

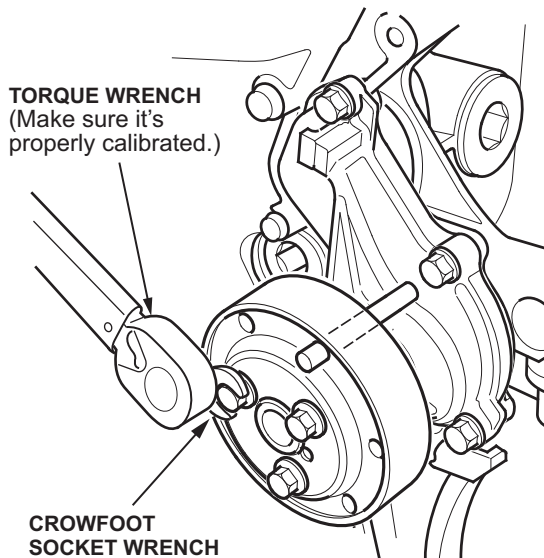
- Reinstall the water pump pulley and its three bolts. Insert the pulley holder in the 12 o'clock position to keep the pulley from moving while you torque the bolts to **14 N·m (10 lb-ft)**.

- The exact torque is critical for a successful repair.** To guarantee the correct torque, you must use an accurately calibrated torque wrench. It's OK to use a crowfoot socket wrench with the torque wrench.
- Do not install the drive belt before you torque the pulley bolts. If you do, you won't get accurate torque readings.
- Remove the pulley holder after you torque the pulley bolts.

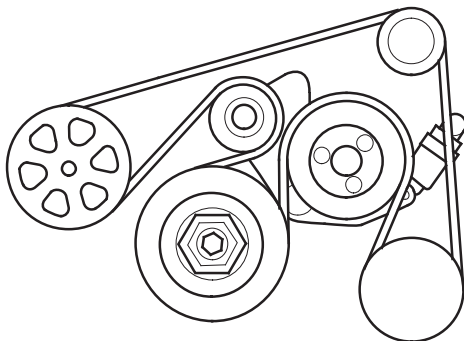
- On vehicles with A/C, route a new drive belt around the engine pulleys as shown below. On vehicles without A/C, route the original drive belt as shown in step 1.

- From above the engine, set a long-handled boxed-end wrench on the drive belt auto-tensioner. Slowly turn the wrench counterclockwise, and slip the belt over the auto-tensioner pulley. Release the auto-tensioner, and remove the wrench.
- Center-punch a completion mark below the 13th character of the engine compartment VIN:
 - Slide open the FRAME NUMBER door on the center cowl cover.
 - Use a long punch to reach the VIN.
