MODEL	SUBJECT		22/03/96
Range Rover Classic	Stalling/Poor Idle/Surging		19/03/96/US
Discovery	AFFECTED VEHICLES		
Discovery	LP	661835 to 663534	
Defender 90	LJ	152765 to 164227	
	LJ	500000 to 515006	
	LD	965085 to 980154

Page 2 of 2	SUBJECT Stalling/Poor Idle/Surging	22/03/96 19/03/96/US
MODEL Range Rover Classic Discovery Discovery Defender 90	AFFECTED VEHICLES LP 661835 to 663534 LJ 152765 to 164227 LJ 500000 to 515006 LD 965085 to 980154

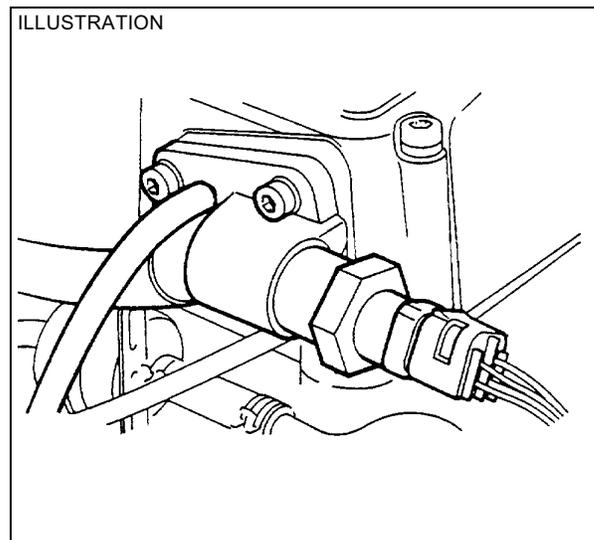
DETAIL
During mid to late 1995 a number of faulty stepper motor (Idle Air Control Valve) castings found their way into production of 14CUX vehicles and the parts supply. This bulletin will help identify the faulty castings and also identify the problems they cause. Problems encountered are as follows:
The restriction caused by the faulty casting affects the idle speed control, especially on cold start.

PROCEDURE
Refer to the Workshop Manual section 19 "Idle Air Control Valve."
Description
1. The aperture on faulty castings is approximately 0.315x0.118 in(8x3mm) (on normal castings the aperture should be 0.433x0.433 in(11x11mm)).
2. Corners marked in illustration are square on faulty castings (normally they should be rounded).
3. On good castings, IACV spring is clearly visible, but more difficult to see on faulty castings.
What to Do
If above symptoms are present and a IACV housing is fitted to vehicle, remove housing, remove stepper motor from housing and file down housing aperture to meet specifications as outlined above. When the IACV is re-fitted use Loctite 242 on the threads before installing. **Remember to RESET IDLE on a fully warm engine and transmission.**

ACTION REQUIRED
Upon customer complaint of stalling/poor idle and surging the air by-pass stepper housing should be removed and checked for the condition stated above, if a faulty motor stepper housing is found follow the below procedure.

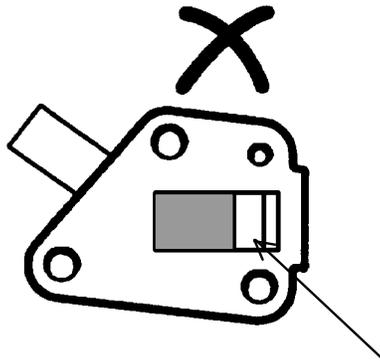
Incorrect aperture size of 3mmX8mm.
