2002 Toyota Camry LE

M.I.L. "ON" DTC P0420

TECHNICAL SERVICE BULLETIN

Reference Number(s): EG024-04, Date of Issue: April 03, 2007; July 27, 2004; July 07, 2004

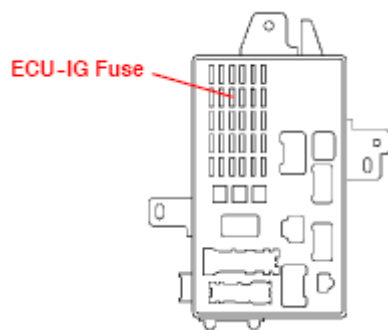
Fig. 2: Identifying ECU-IG Fuse Location
 Courtesy of TOYOTA MOTOR SALES, U.S.A., INC.

NOTE: ECU damage may occur if the 10A fuse is NOT removed.

3. Remove the 10A ECU-IG fuse from the instrument panel Junction Block (refer to **Fig. 2** for location). This action prevents possible activation of the ABS relay, resulting in ECM Reprogramming failure.
