Product Update: Drive Belt Auto-Tensioner Pivot Bolt Replacement

The repair is to replace the drive belt auto-tensioner pivot bolt and reroute the drive belt. On vehicles with A/C, a new drive belt is used in the repair. For repair, affected VIN, and warranty information, refer to Service Bulletin 09-007, *Product Update: Drive Belt Auto-Tensioner Pivot Bolt Replacement*.

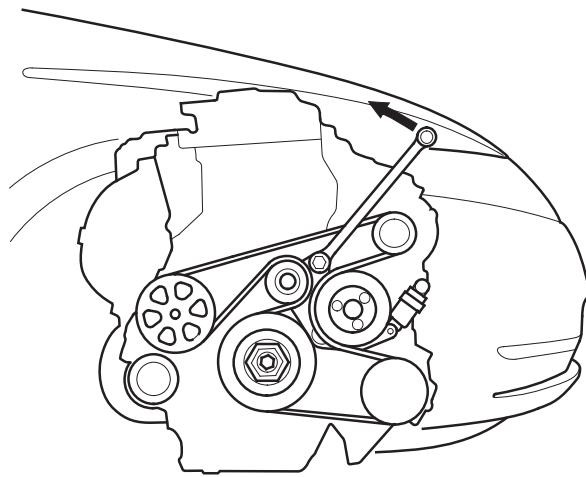
WITH A/C

1. From above the engine, set a long-handled, boxed-end wrench on the drive belt auto-tensioner. Slowly turn the wrench counterclockwise, then remove the drive belt.

NOTE: On vehicles without A/C, the drive belt will be reused.

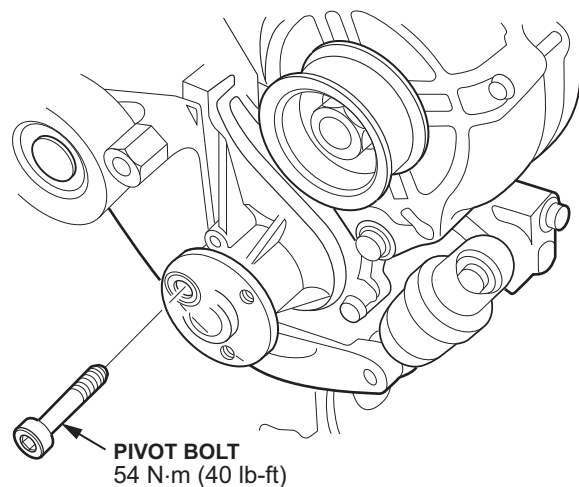
NOTE: In rare cases, the pivot bolt may be broken. If this has happened, remove the auto-tensioner, then remove the shank of the pivot bolt with Vise Grips or by drilling it out. *Do not try to repair the engine block using a TIME-SERT.* If you can't remove the shank of the pivot bolt, you would need DPSM approval to install an engine short block assembly.

3. Remove the water pump pulley (three bolts).
4. Remove the pivot bolt from the drive belt auto-tensioner.

- Install a new pivot bolt on the auto-tensioner, and torque it to **54 N·m (40 lb-ft)**.
