## FORD BLEND DOOR FIX (EXPLORER, RANGER, EXPEDITION)

If your climate control only has two settings: HEAT and MAX A/C then the chances are this fix will work for you.

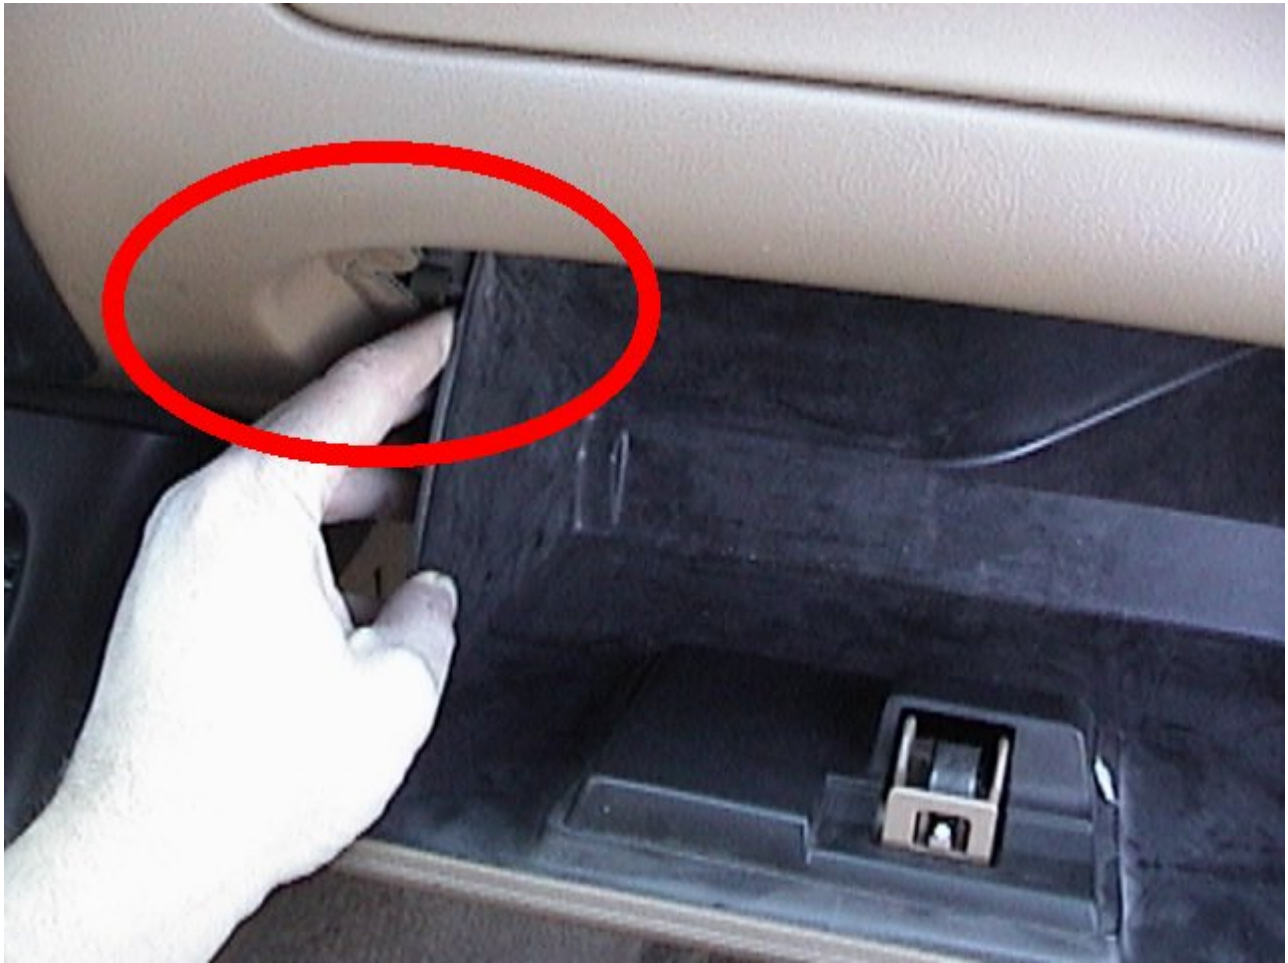
Step 1:

Remove the glove box to gain access to the plenum. There is a release on the left hand side of the glove box.

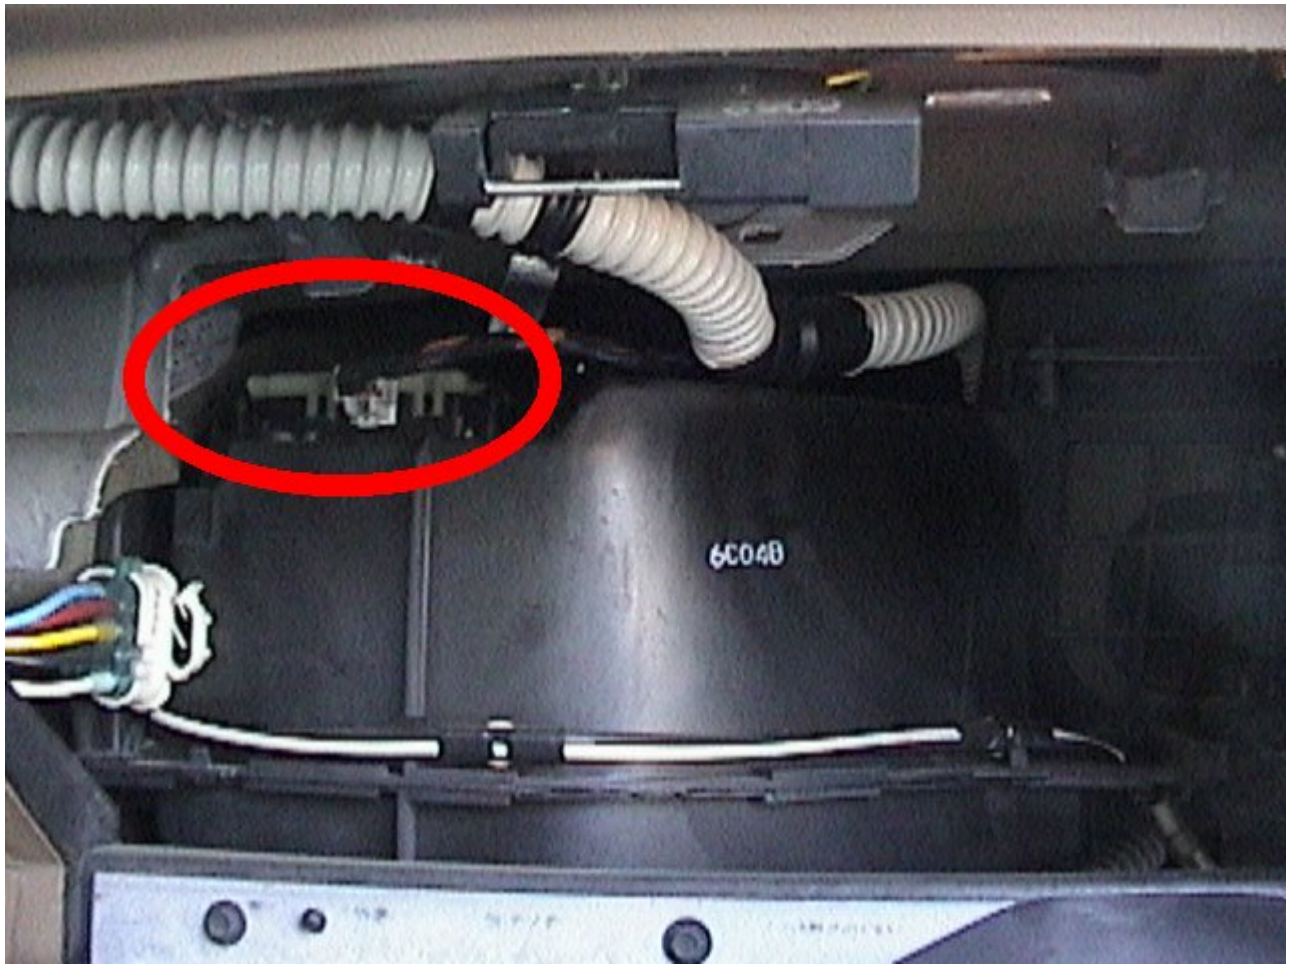
Step 2:

Locate the actuator. The actuator is a flat white box that sits on 4 clip posts on the top left of the plenum. It has a wiring harness coming out of the front.

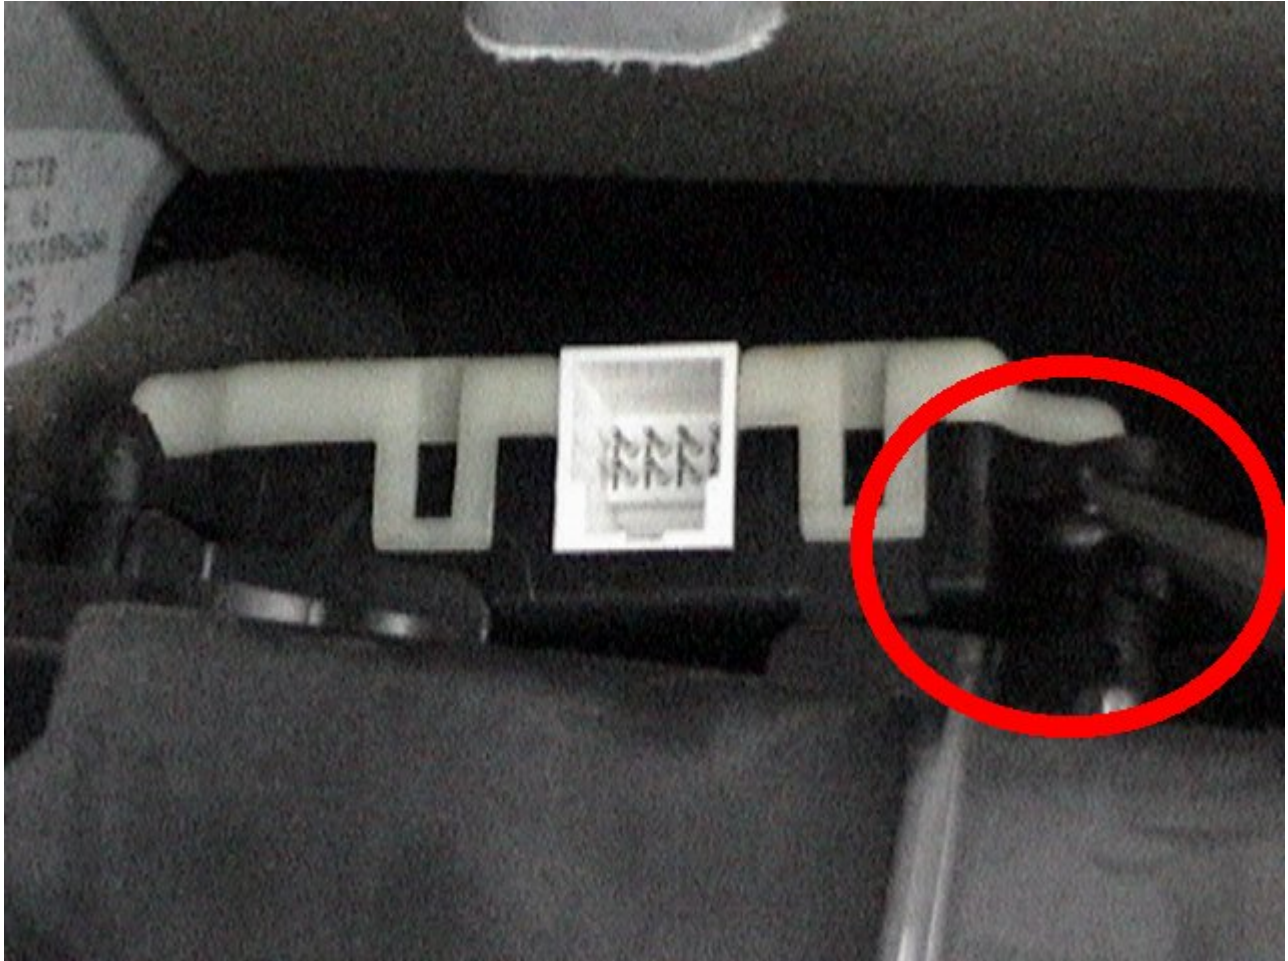
Step 3:

Remove the actuator. Use a flat head screwdriver to pry up the actuator. Pry up the front first and then put the screwdriver under it to pop up the back. (Note: I unplugged the wiring harness when I removed mine. If you also unplugged the wiring harness you will need to plug it back in before doing step 4).

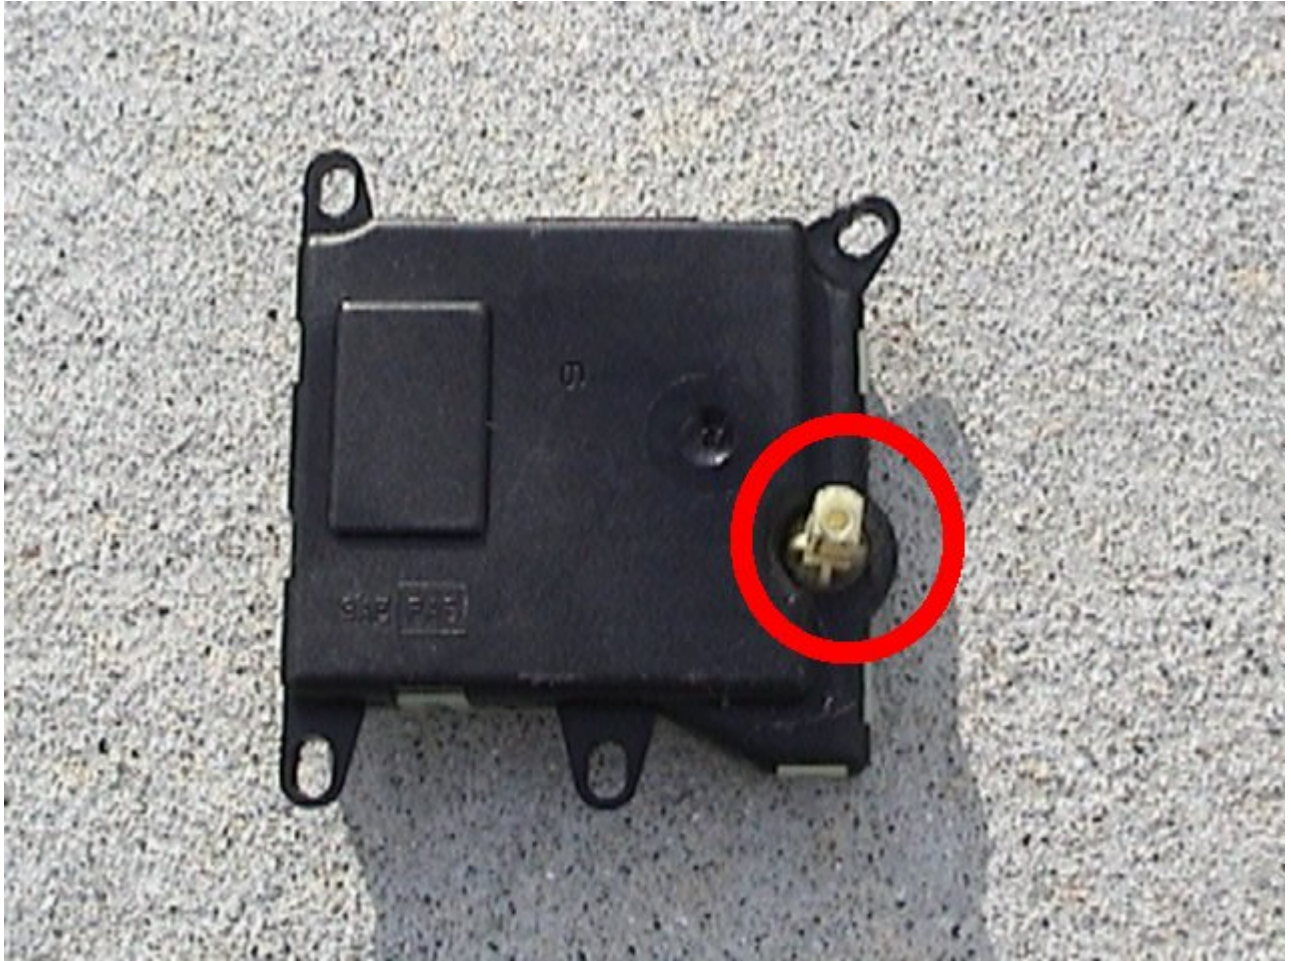
#### Step 4:

On the bottom of the actuator there is a “D” shaped pin. Turn on the ignition and move the heater control on the dash. You should see the pin rotate (wiring harness must be attached!). If the pin does not rotate then you have a different problem (bad actuator, terminals corroded, etc). If the actuator does move, set the heater control to full heat and turn the blower on high. **THIS IS VERY IMPORTANT.** It moves the actuator to the correct position for the fix.

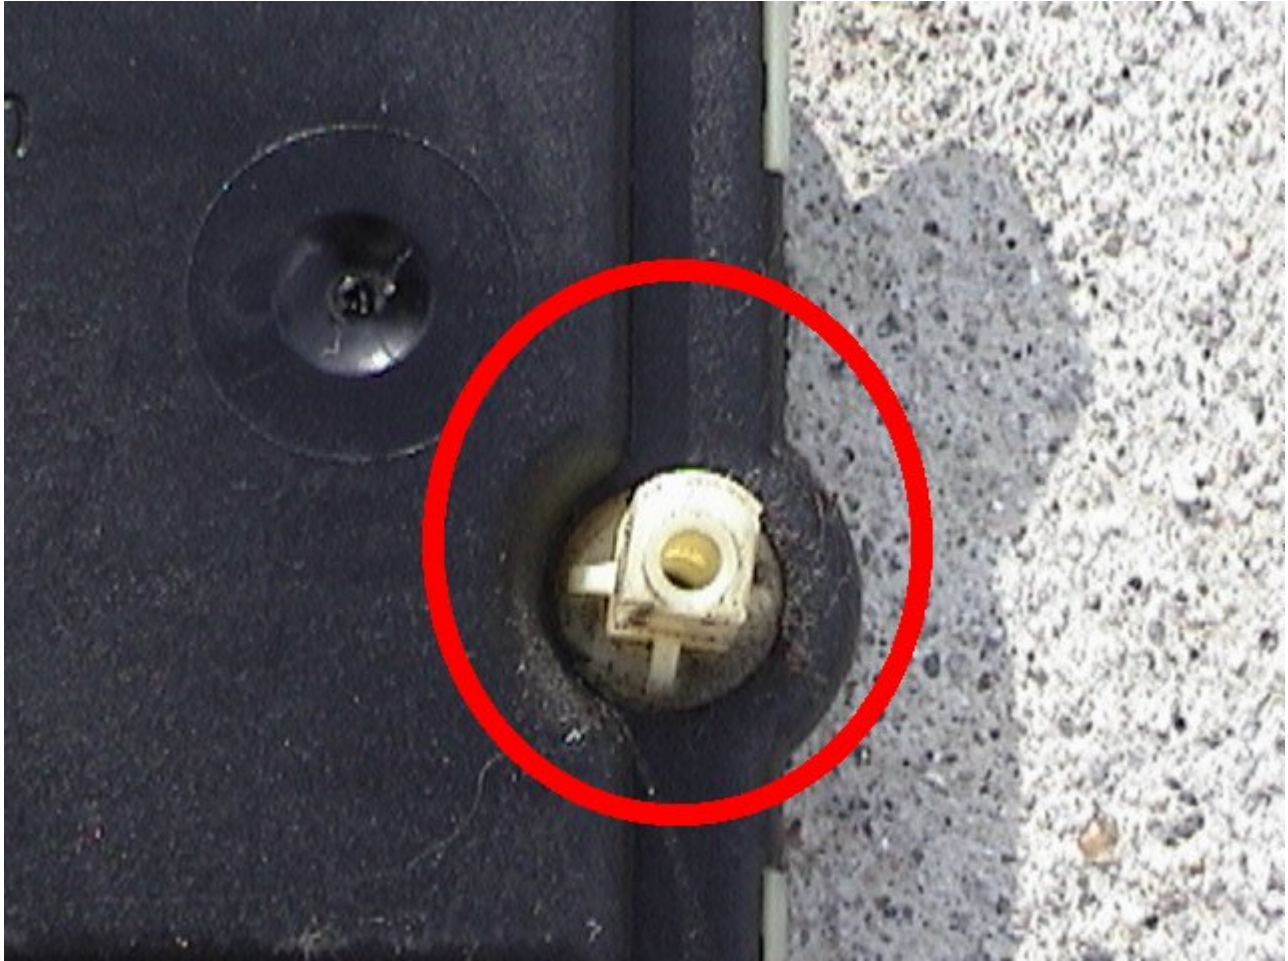
Actuator "D" shaped pin.

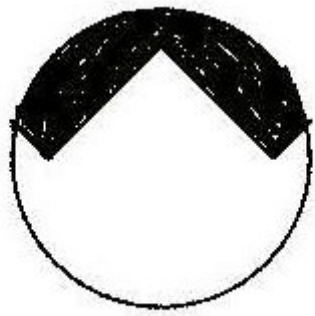
Using a small dentist mirror and flashlight, look into the top of the box where the actuator pin goes. You should see that the chamber is half missing. It should look similar to the drawing below:

Towards the rear of vehicle

They all break roughly in the same spot. If it looks like the drawing above then drill a hole (I used a 1/16 in drill bit) in the actuator pin in the location in the drawing below:

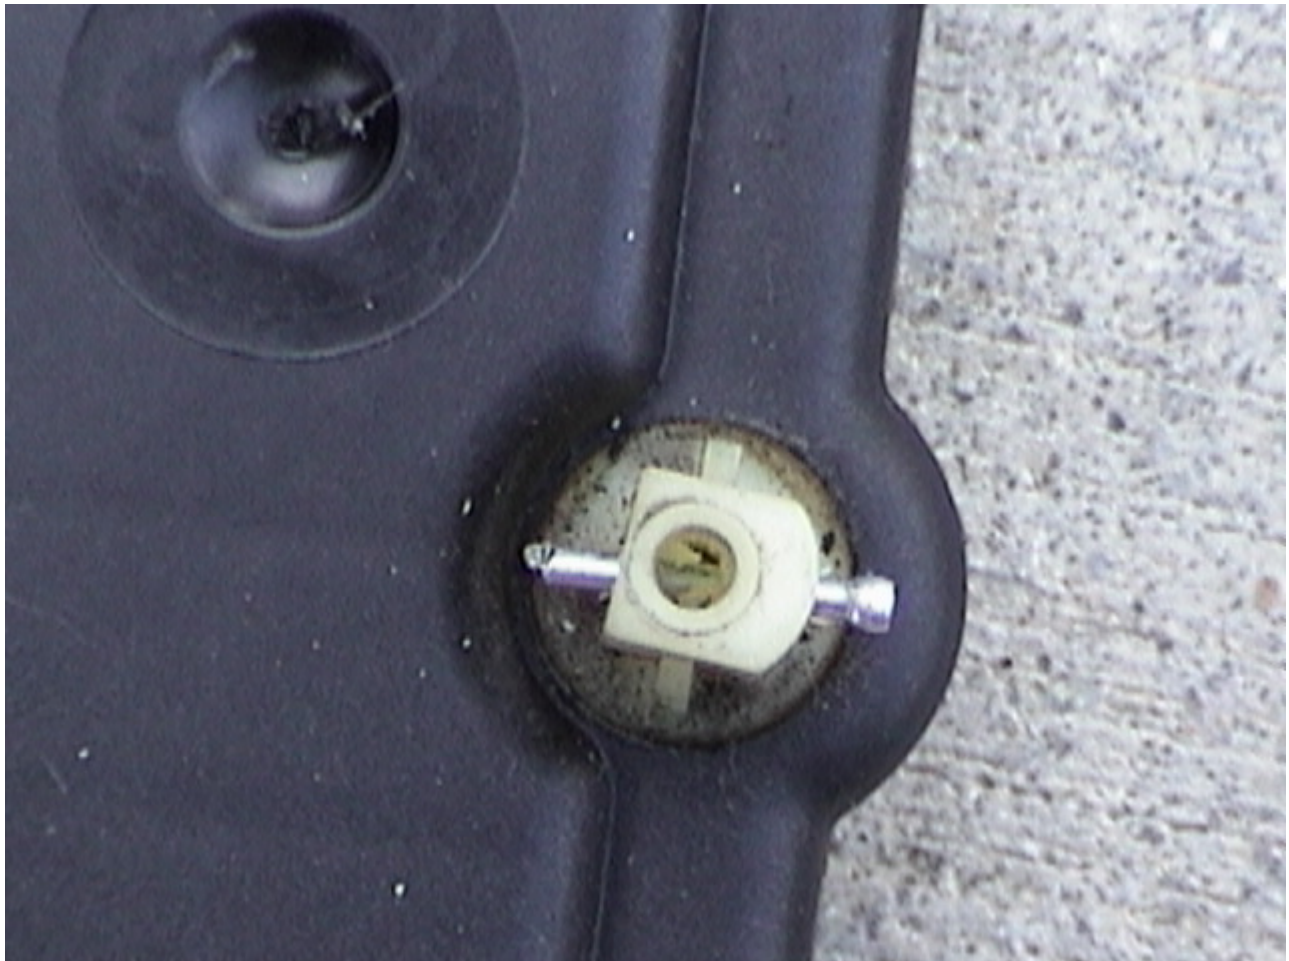
Step 7:

After drilling the hole insert a metal rod. I used a cut down finishing nail. Others have used a cut down drill bit. Be sure to have about 1/8 in on either side of the pin. Be sure it is snug in the hole.

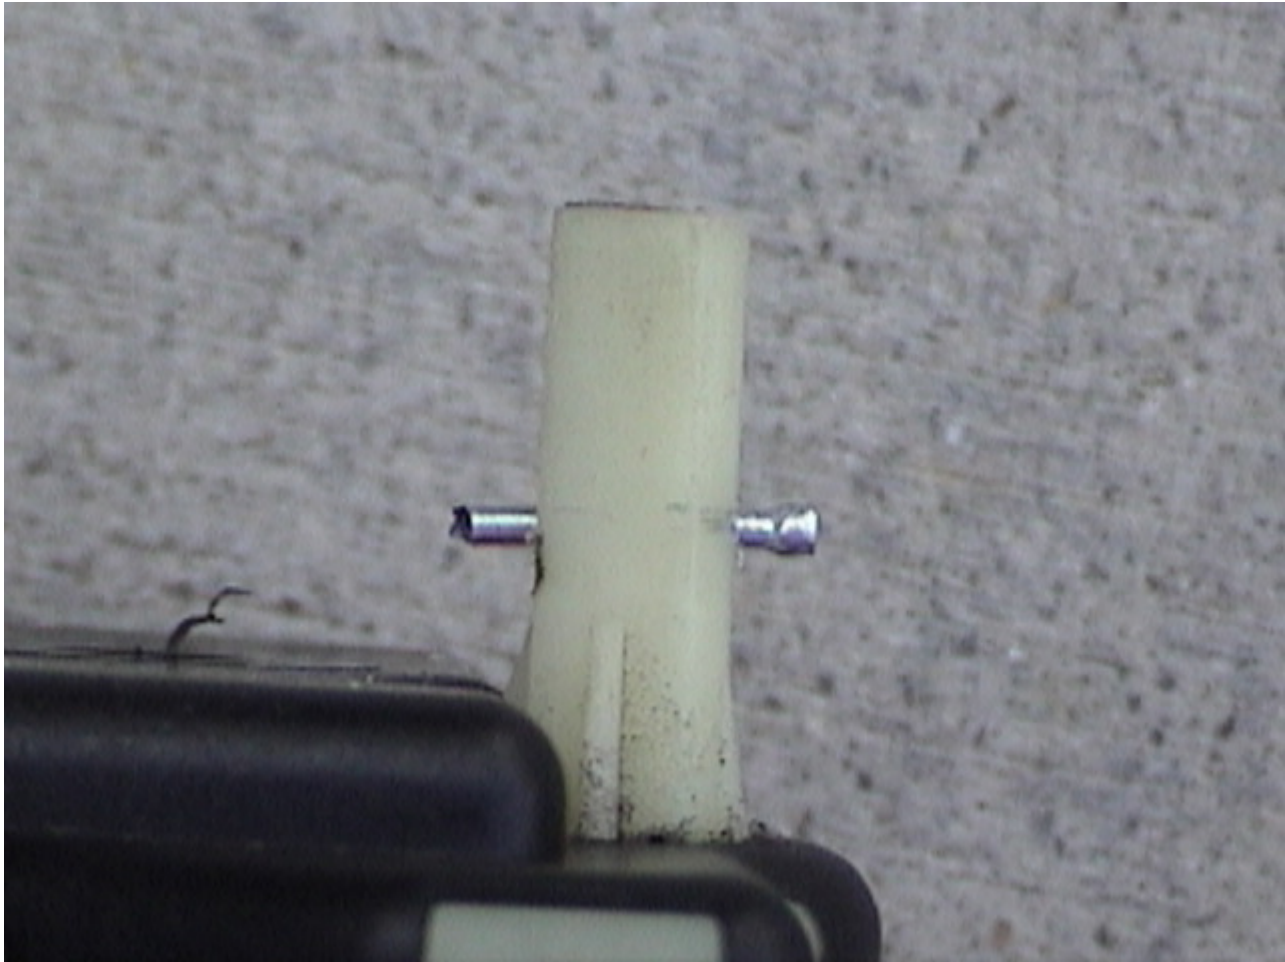
Close up of fix. Drilled out with 1/16 in drill bit and cut down finishing nail.

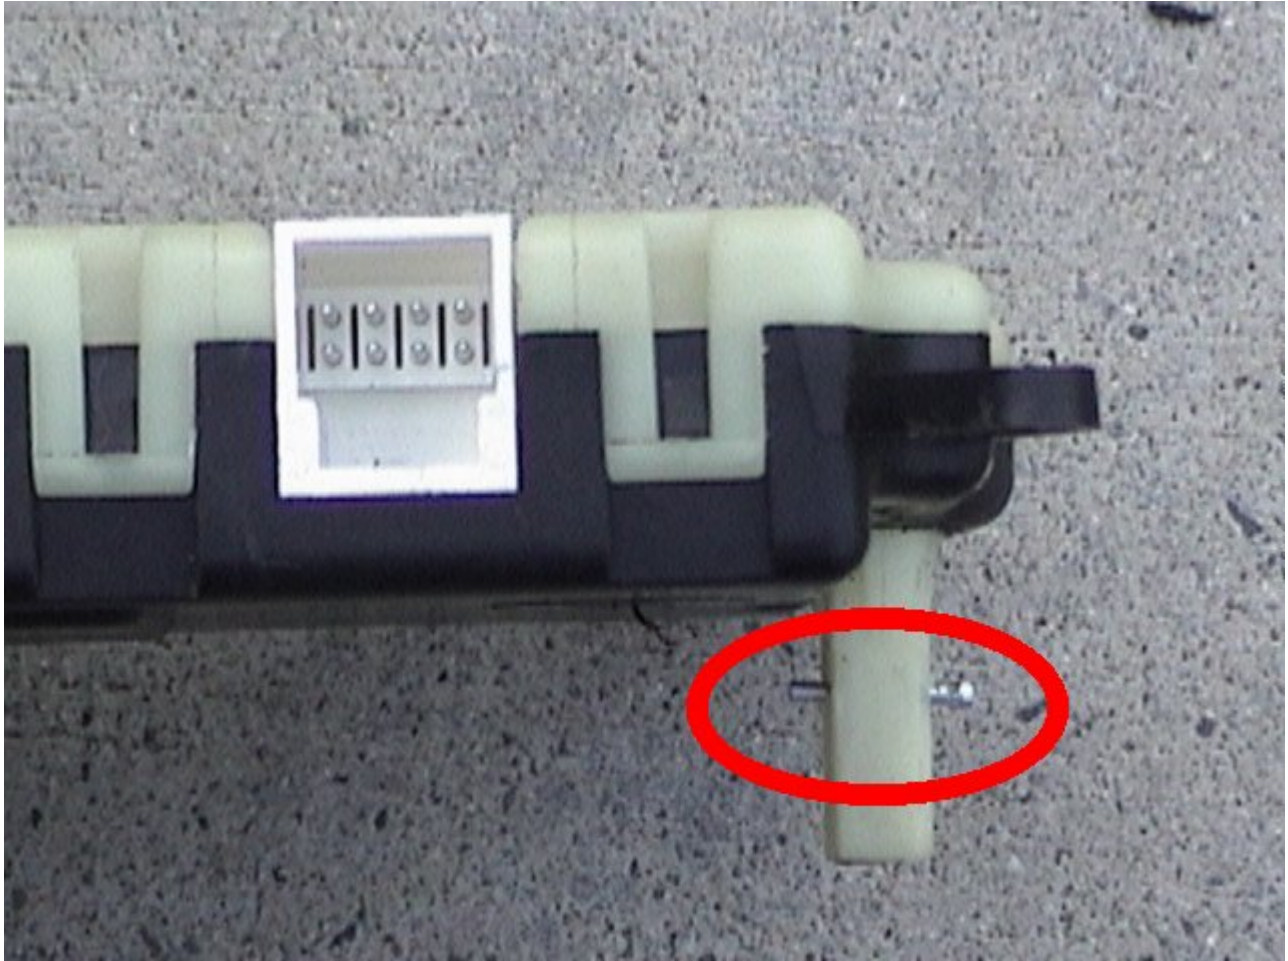
Close up of fix - side view.
