REPLACEMENT

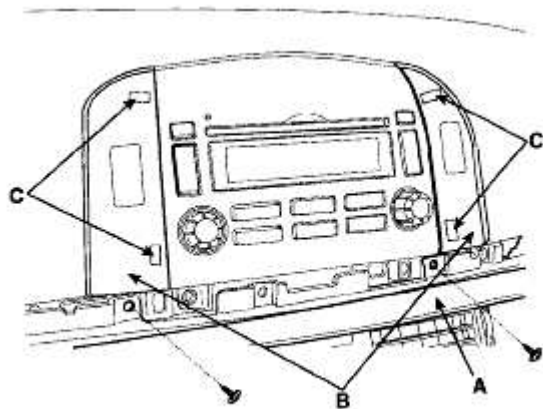
ETRF021B

Fig. 10: Identifying Crash Pad Garnish, Center Facia Panel And Clips
Courtesy of HYUNDAI MOTOR CO.

1. Disconnect the negative (-) battery terminal.
2. Remove the crash pad garnish (A) after pulling it by using regular screw driver (-). Take care of fixing clips (C).
3. Remove the center facia panel (B) after loosening the screws.

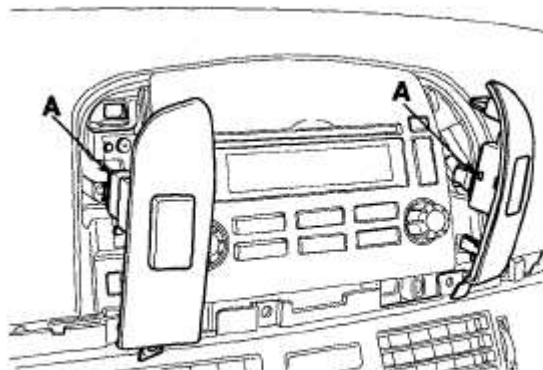
LSRE170G

Fig. 11: Identifying Connectors
Courtesy of HYUNDAI MOTOR CO.

4. Remove the connectors (A).

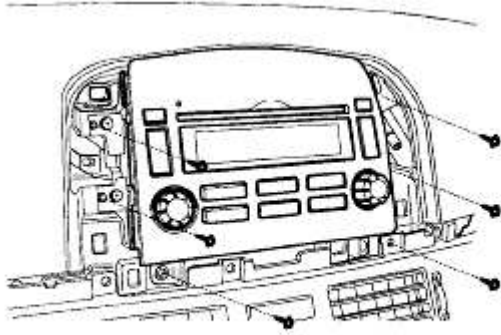
ETRF021C

[Fig. 12: Identifying Audio Unit Mounting Screws](#)
Courtesy of HYUNDAI MOTOR CO.

5. Remove the mounting screws then remove the audio unit (A).
