Applies To: **2005–07 Odyssey** – All Models With Rear Entertainment System

RES Headphones Don't Work in DVD Mode

(Supersedes 07-084, dated January 18, 2008, to update the information marked by the black bars)

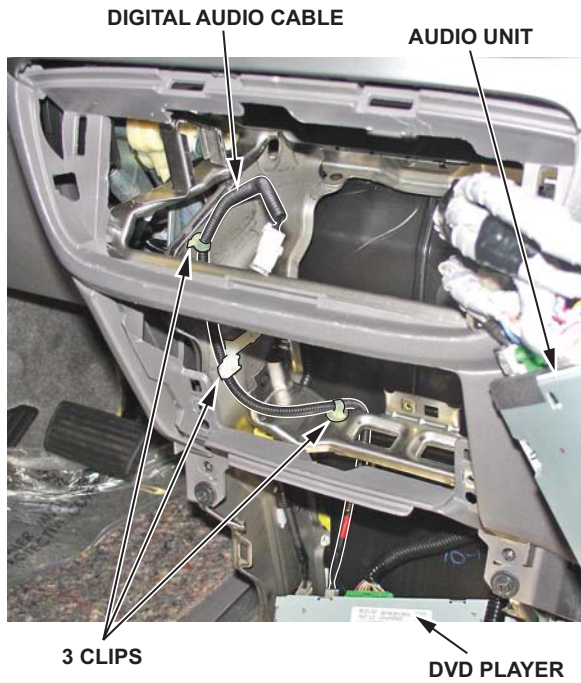
2. Detach the three clips, and remove the digital audio lead.

NOTE: Model with navigation is shown; other models are similar.

3. Install the new digital audio lead. Follow the routing of the original lead, and attach the three clips.
4. Reinstall all remaining parts.
5. Make sure the headphones work in AM/FM/CD and DVD modes.
