Transmission Speed Sensor: Customer Interest

Number:
05-40-011

Model:
1999 - SONATA,
2001 - ELANTRA, SANTA FE, XG
2003 - TIBURON
2005 - TUCSON

Subject
AUTOMATIC TRANSAXLE DIAGNOSTIC TROUBLE CODES P0715, P0717, P0720, P0721, P0722

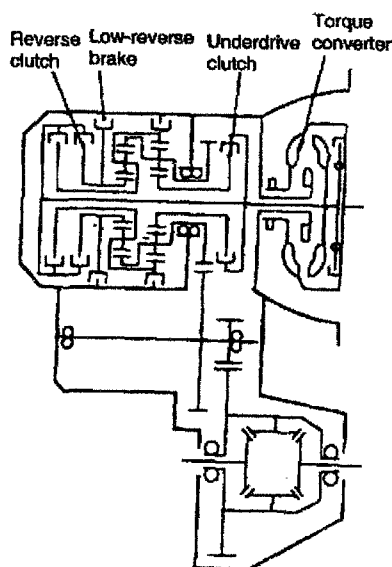
EKA9006A

TORQUE CONVERTER STALL TEST JUDGEMENT RESULTS

1. Stall speed is too high in both D and R ranges
 - ^ Low line pressure
 - ^ Low & reverse brake slippage
2. Stall speed is too high in D range only
 - ^ Underdrive clutch slippage
3. Stall speed is too high in R range only
 - ^ Reverse clutch slippage

4. Stall speed too low in both D and R ranges
 - ^ Malfunction of torque converter
 - ^ Insufficient engine output

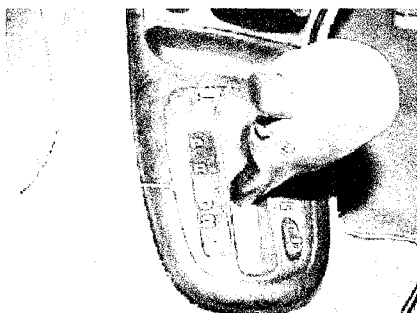
1. Attach a Hi-Scan Pro and select "Automatic Transaxle" menu, "Current Data" menu and "Fluid Temperature".
2. Drive the vehicle until the ATF is at normal operating temperature 70-100°C (158-212°F).
