^ Transmission: 41TE/A604
^ Subject: Intermittent limp-in/Fault codes
^ Application: Chrysler

41TE/A604

Intermittent Limp-in/Fault Codes

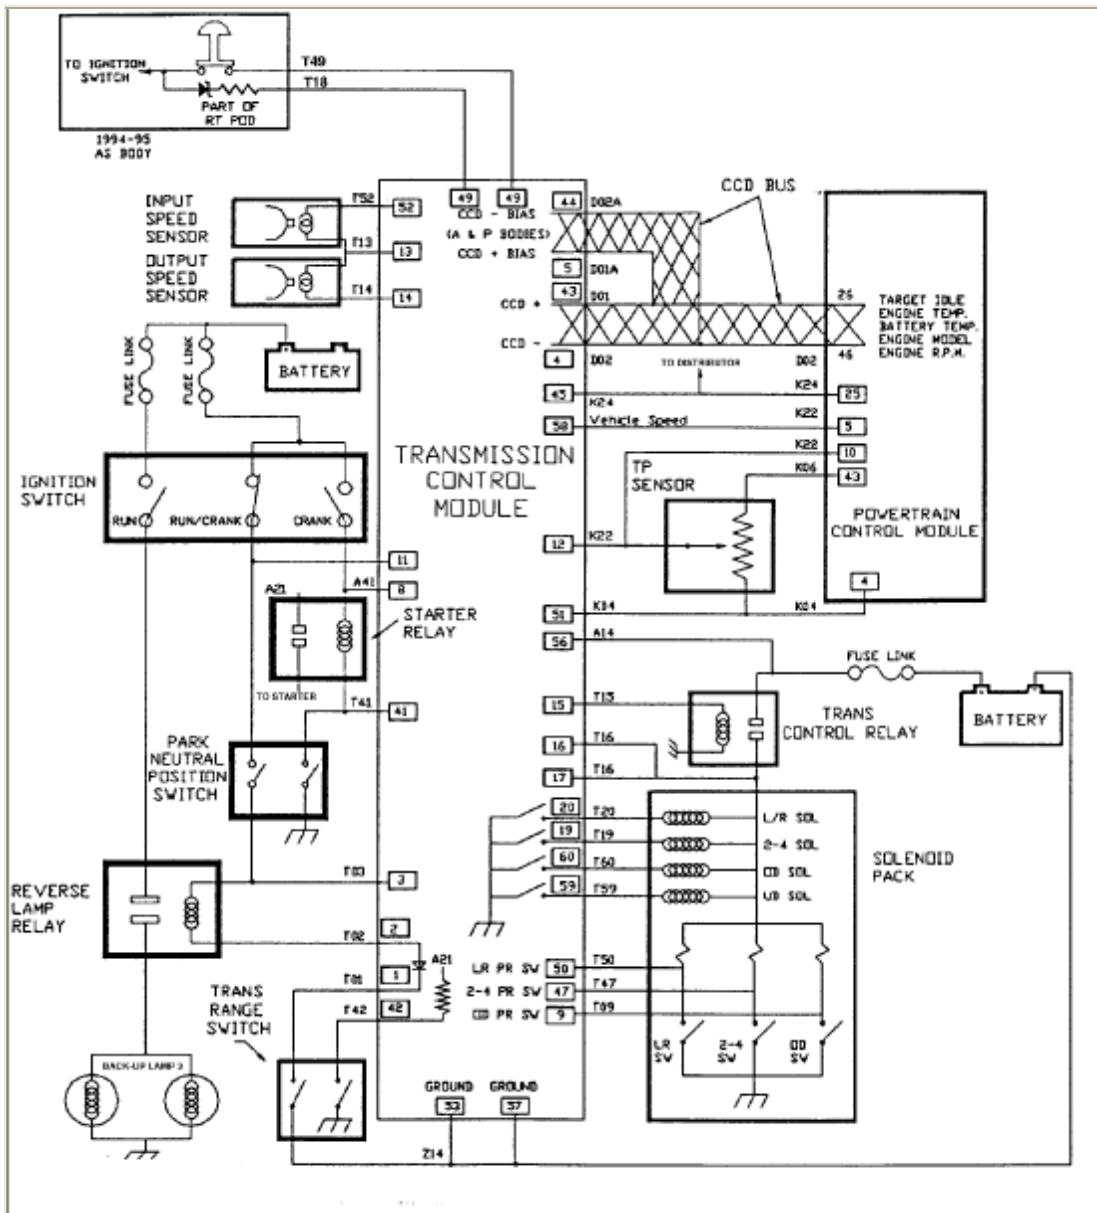
An intermittent limp-in/fault codes condition can be caused by poor electrical connections to any of the input/output devices used by the controller. Make sure all of the connections are tight and there are no bent terminals in the connectors.

NOTE: The most common codes related to this problem are: 21-27, 31-33, 36-39, 41-44 and 50-58.

Chrysler has two repair kits available in the event that the harness connector for the speed sensors or solenoid assembly are damaged. The part numbers are listed below.

Solenoid harness repair kit 4419476
Speed sensor harness repair kit 4419478
