## Radio, Stereo, and Compact Disc: Service and Repair

### AR82.60-P-7605V Remove/install Audio Components Center

- with CODE (525) MB Audio 50 APS radio

- with CODE (527) COMAND APS with single DVD drive (with navigation)

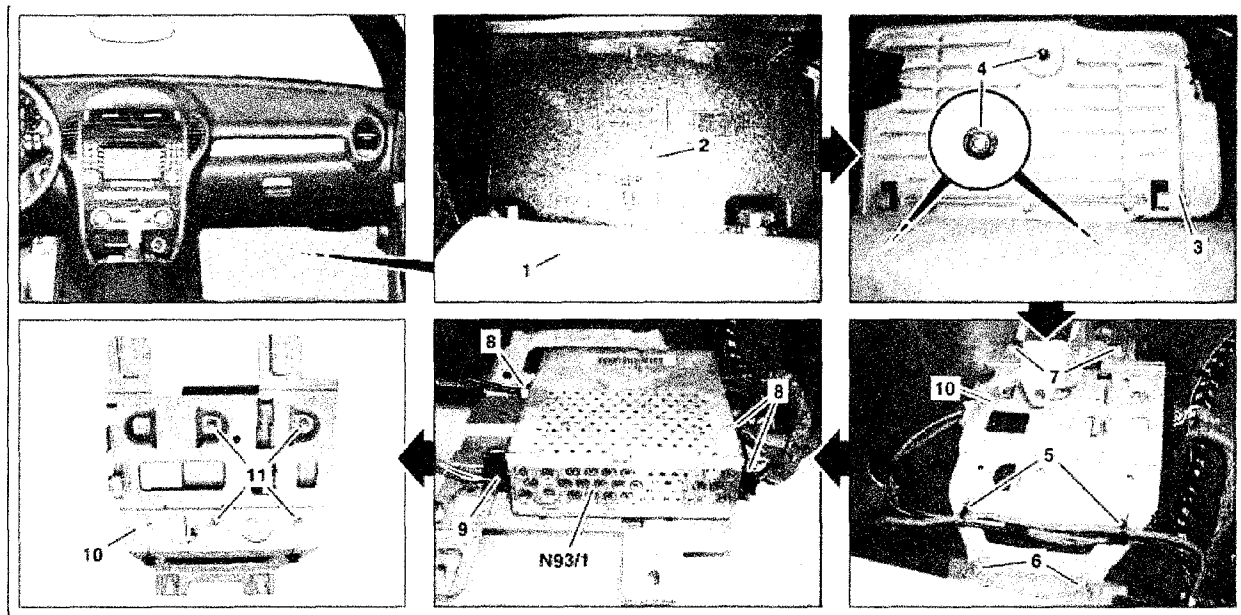
P82.60-4351-09

- 1 Floor mat
- 2 Impact damper
- 3 Step plate
- 4 Nuts
- 5 Tie strap

- 6 Nuts
- 7 Bolts
- 8 Electrical connectors
- 9 Fiber optical cable connection
- 10 Equipment carrier

- 11 Nuts
- N93/1 Audio gateway control unit

e d	Removal/installation		
1.1	Put basic data of audio gateway control unit (N93/1) into intermediate storage in STAR DIAGNOSIS	When replacing audio gateway control unit (N93/1).  ↓ Installation: Transmit basic data from intermediate storage to new audio gateway control unit (N93/1).	
H	Connect STAR DIAGNOSIS, read out fault memory	STAR DIAGNOSIS diagnosis system	AD00.00-P-2000-04A *WE58.40-Z-1013-06A
2	Move front passenger seat to end position toward rear	↓ See Operating Instructions	
3	Disconnect battery ground line		AR54.10-P-0003V
4	Fold floor covering (1) towards rear at front passenger side		
5	Remove impact absorber (2) from step plate (3)	↓ Installation: Ensure that impact absorber (2) is correctly seated in clips of step plate (3).	
6	Undo nuts (4) and remove step plate (3) from front passenger side footwell		
7	Detach tie strap (5)	↓ Installation: Replace tie straps (5).

8.1	Remove ETC [EGS] control unit from equipment carrier (10) and put aside with electrical connections attached	With TRANSMISSION 722.6	AR27.19-P-1719V
9	Unscrew nuts (6) and bolts (7)		
10	Turn equipment carrier (10) with audio gateway control unit (N93/1) over and disconnect electrical connections (8)		
11	Disconnect fiber optical cable connector (9)		
12	Cover up the fiber optical cable connector (9)		AR82.95-P-0005-01A
13	Remove audio gateway control unit (N93/1) with equipment carrier (10) from front passenger side footwell

14.1	Unscrew nuts (11) and remove audio gateway control unit (N93/1) from equipment carrier (10)	Only when replacing audio gateway control unit (N93/1).	
15	Install in the reverse order
